**NORTHLAND
POWER**

Abitibi Solar Project

Draft Water Body Site Investigations Report

H334844-0000-07-124-0247

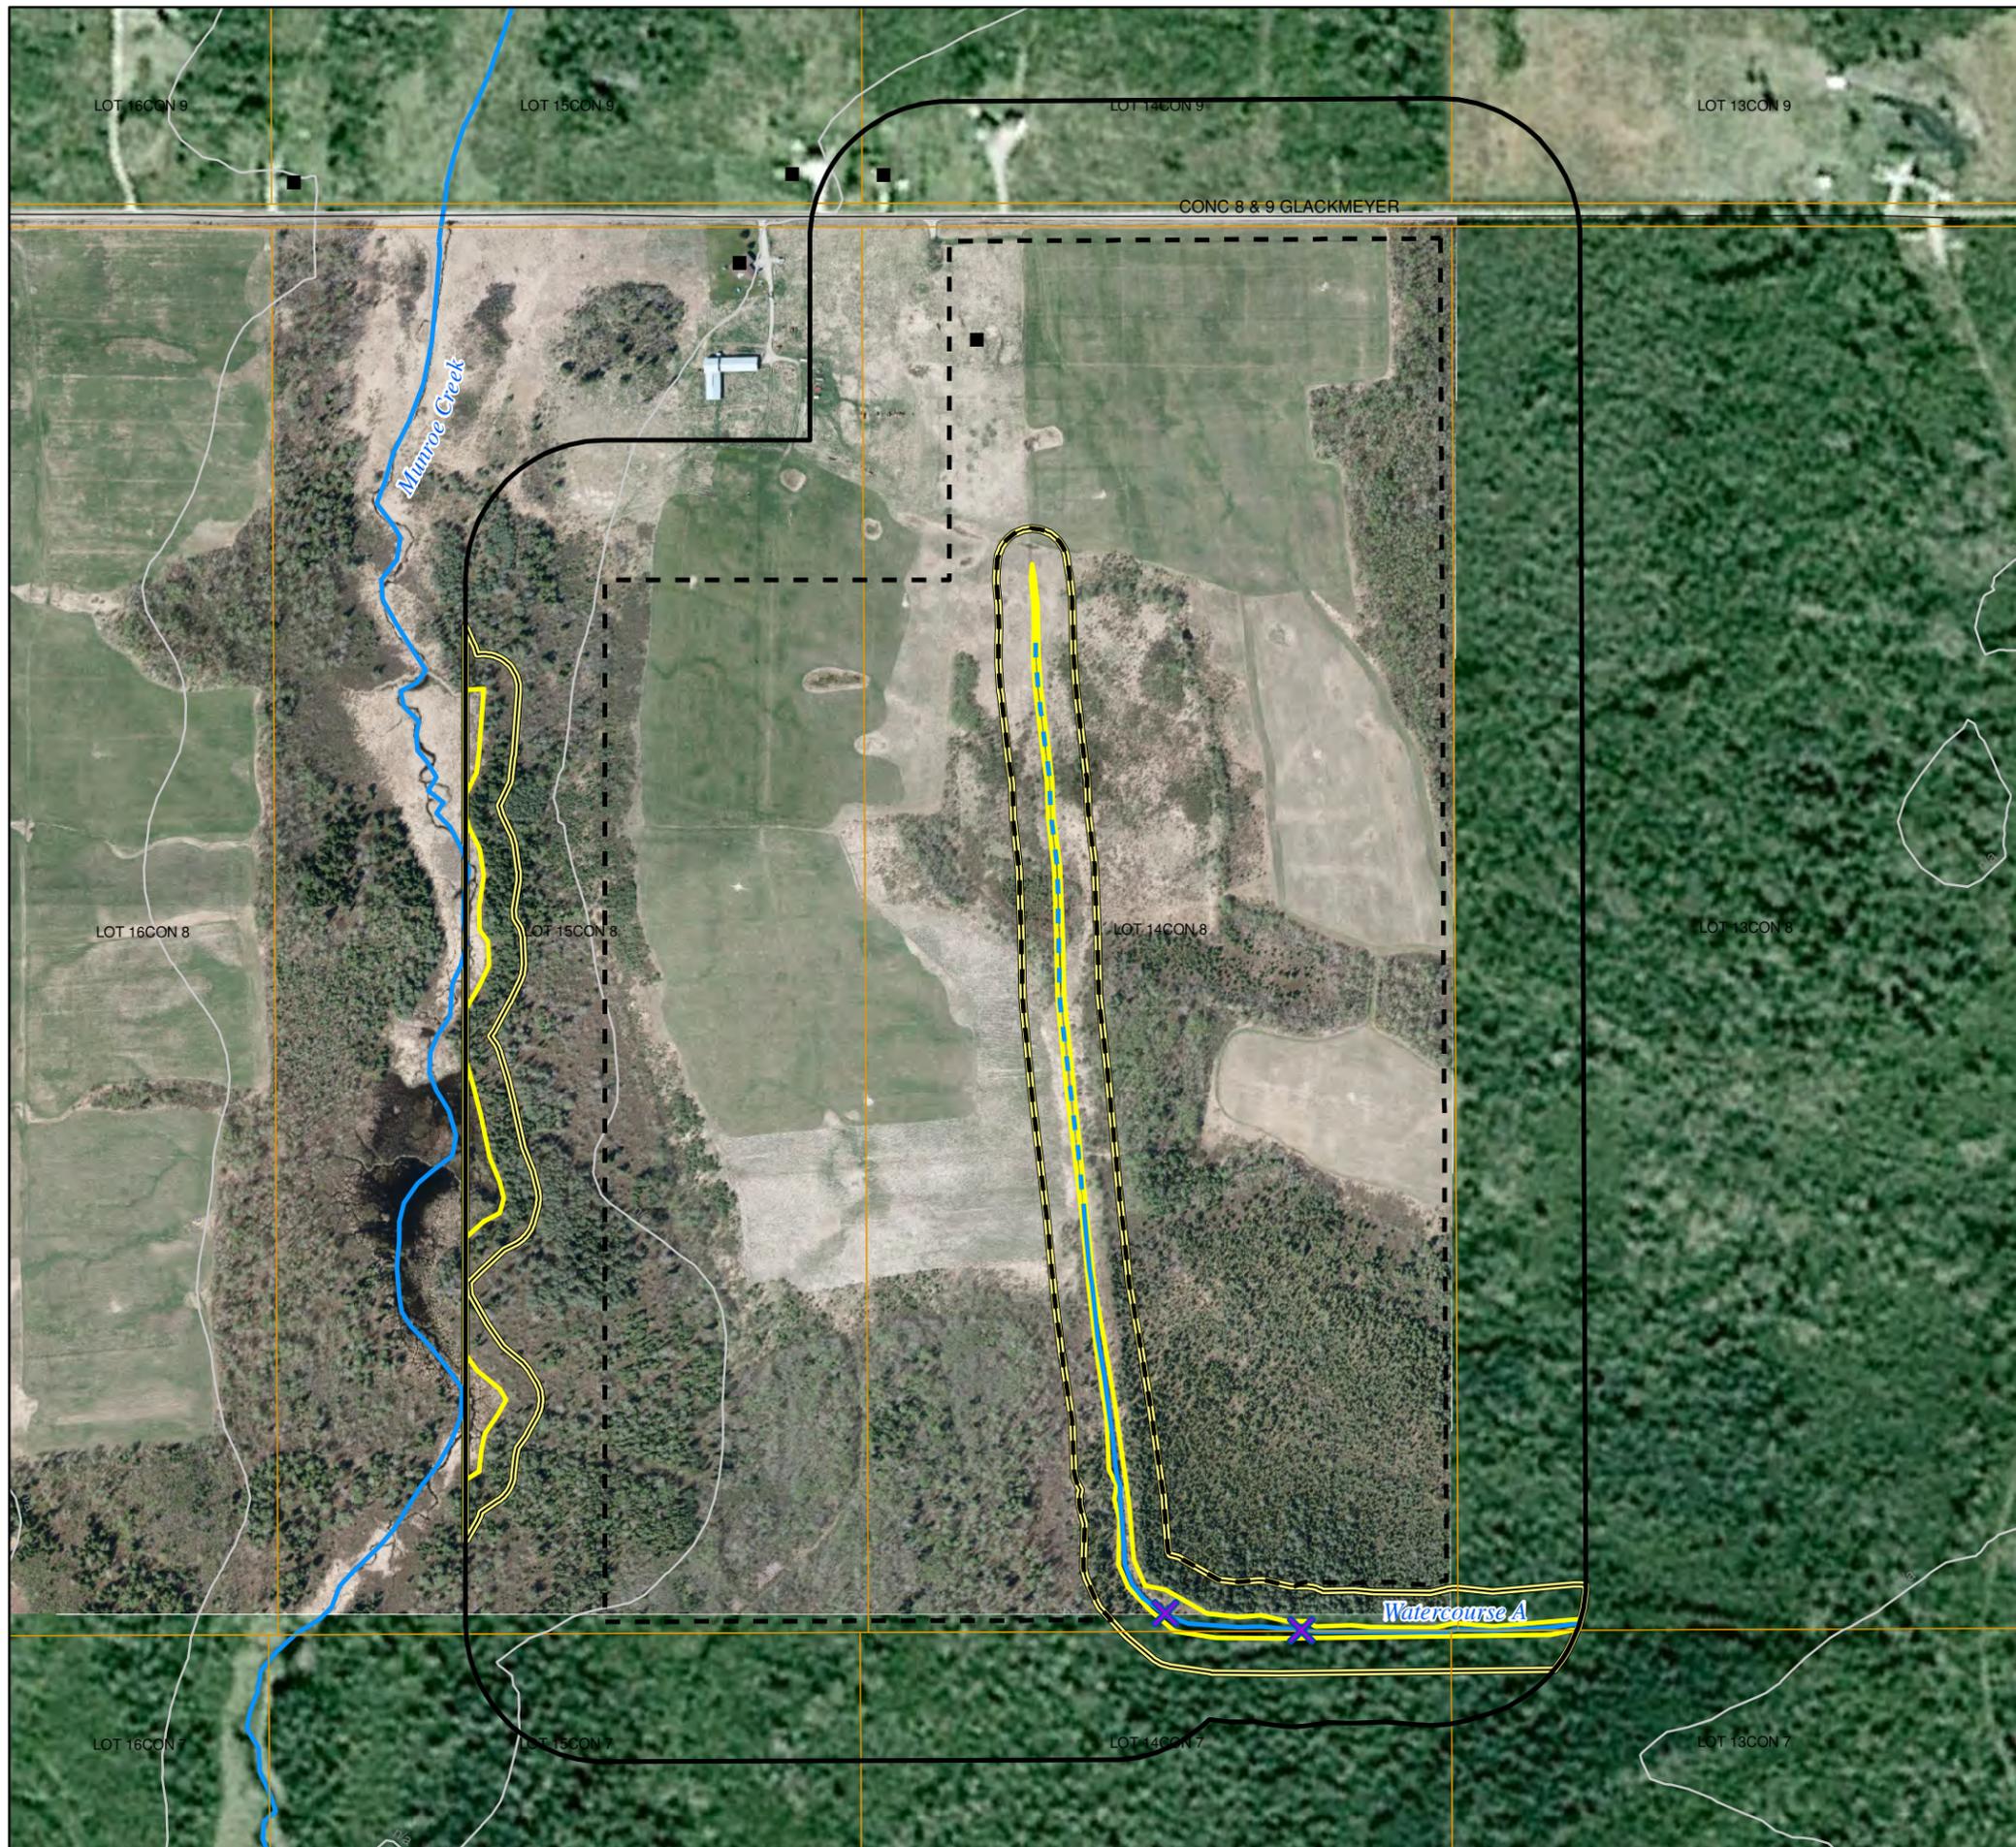
Figure 1.1
 Northland Power Inc.
Abitibi Solar Project
Water Body Site
Investigation Results

As shown in Figure 1.1 and summarized in Table 5.1, the solar panel Project Location is located between 30 and 120 m from the average annual high water mark of Watercourse A and Munroe Creek. The proposed access road and connection line to adjoining solar facility will cross Munroe Creek. In addition, the proposed distribution line Project location will cross or run within 120 m of approximately 38 waterbodies, depending on the final route selected. As a result, a *Water Body Environmental Impact Study* is required and will be prepared to address potential negative environmental effects to the identified water body features associated with the proposed development. Recommendations on mitigation measures will be provided to ensure the long-term ecological health and integrity of these water body features.

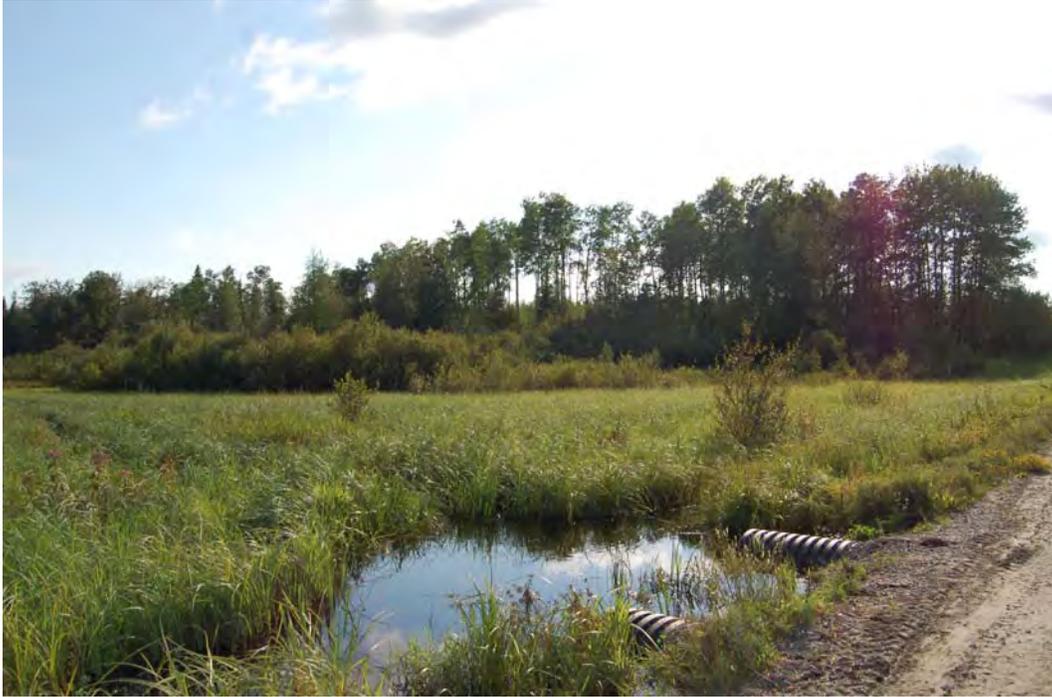
Figure 4.1 View of Munroe Creek from the South Side of Glackmeyer Concession Road 9

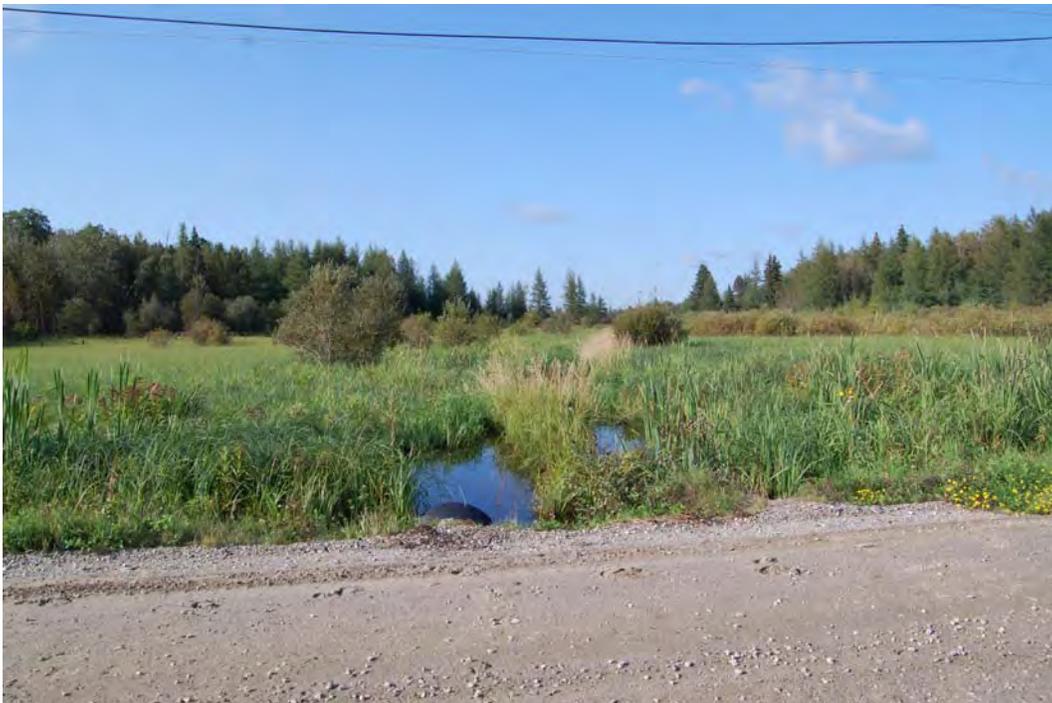
Figure 4.2 View of Munroe Creek from the North Side of Glackmeyer Concession Road 9

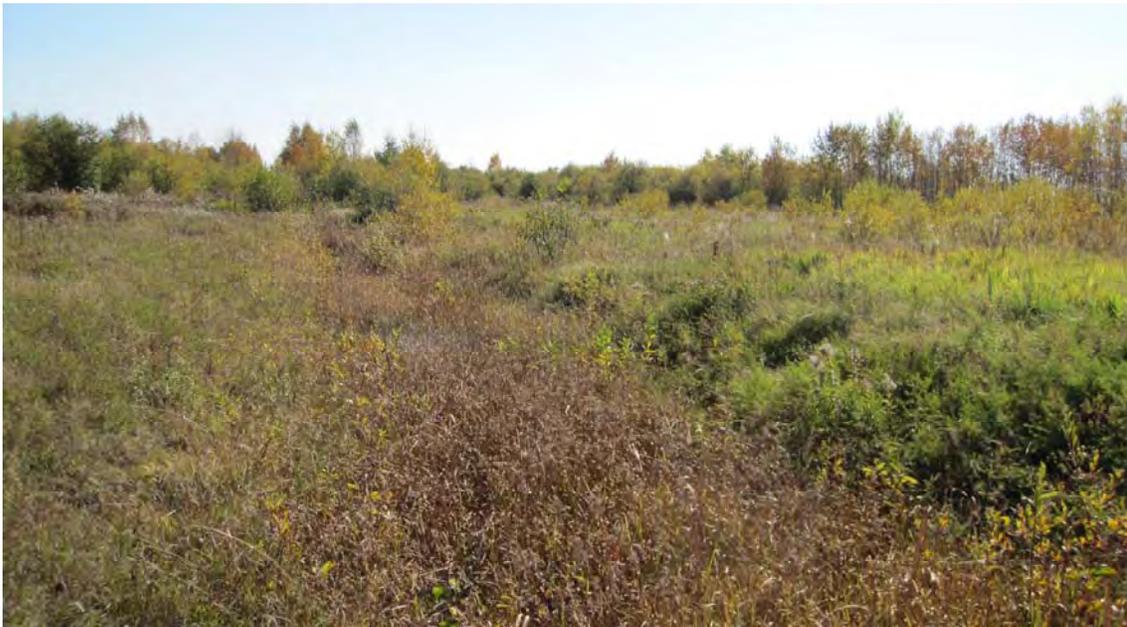
Watercourse A is both an intermittent and permanent stream that originates in an agricultural field on the north-central portion of the property on which the Project is located (Figure 1.1). The intermittent reach of Watercourse A occurs at its point of origin and continues south for approximately 100 m (Figure 4.3). This 100 m reach has a channel-width of approximately 3 m, with 1.5 m high banks. The average annual high watermark was determined to be top of bank. Although highly variable, standing water was noted in several areas, and ranged from approximately < 1 to 10 cm in depth, with a muck bottom. No flowing water was present along this stretch of Watercourse A. The channel was found to contain water-favouring wetland meadow species such as cattails, sedges, rushes and grasses. Riparian vegetation consisted of mainly grasses and small shrubs (Figure 4.3).

Figure 4.3 View of the Initial, Intermittent Stream Portion of Watercourse A, Facing South

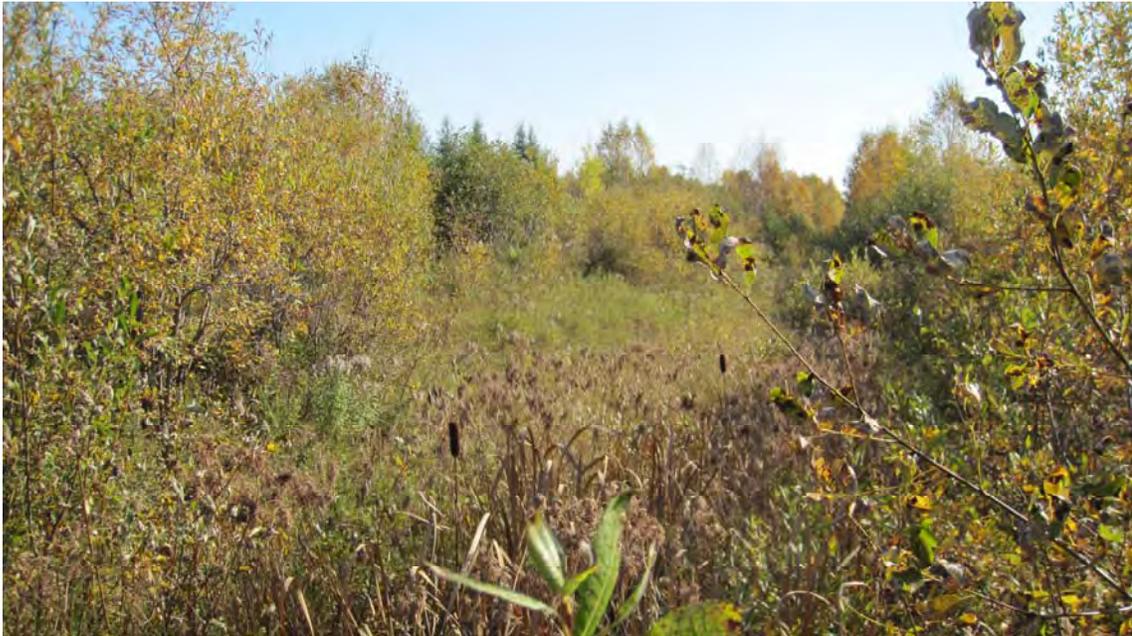
As Watercourse A extends in a southern direction near the central portion of the Project Location, it enters a thicket area of dense in-stream and riparian vegetation for approximately 200 m (Figure 1.1). In this area, the watercourse continues to exist as an intermittent stream, with a channel width of approximately 4 to 6 m and gradually sloping, 2 m high banks. The average annual high water mark was determined to be approximately 10 to 12 m across from bank to bank. Standing water was highly absent, but was present in several areas at depths ranging from approximately < 1 cm to 10 cm, with leafy/muck bottom. No flowing water was present along this stretch of the channel. In-stream vegetation ranged from water-favouring species such as cattails and sedges, and small trees/thick shrubs and bushes, such as alders, willows and dogwoods (Figure 4.4).

Figure 4.4 View of Intermittent Stream Portion of Watercourse A as it Passes through Dense Thicket, Facing South

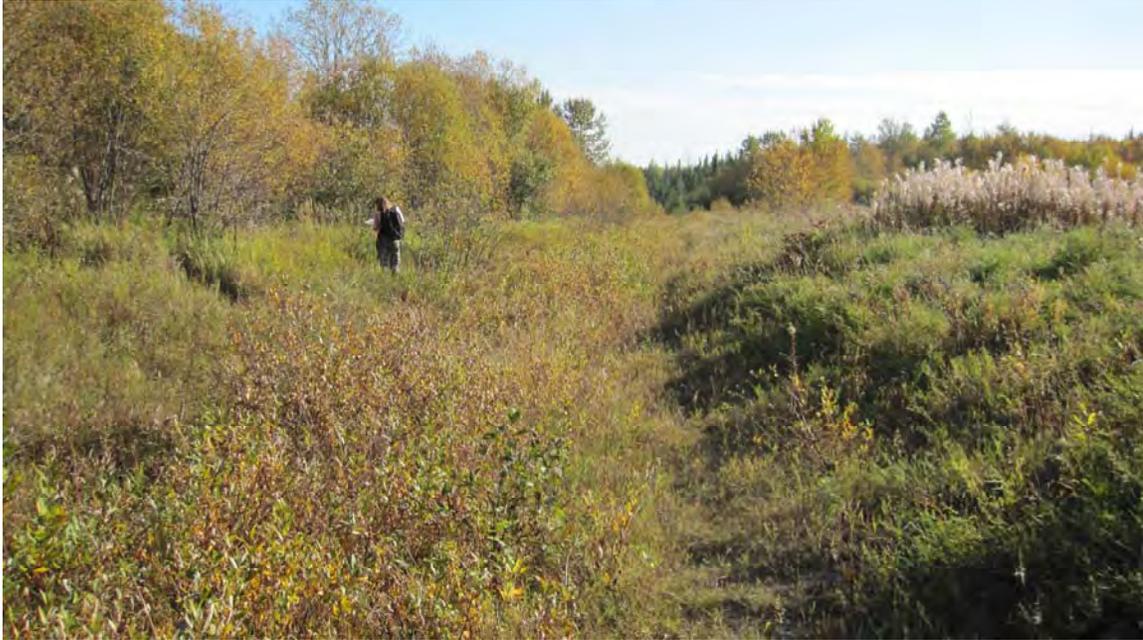
After passing through dense thicket, Watercourse A continues to exist as an intermittent stream, and extends southward next to an agricultural field that is situated to the west (Figure 1.1). During this stretch, the channel width increases to approximately 7 to 10 m width, with relatively large, steep banks approximately 2 to 2.5 m high. The average annual high water mark was assessed to be just below the top of the 7 to 10 m wide banks. No standing water was present along this 200 m stretch of Watercourse A during the time of the site investigations. Riparian and in-stream vegetation primarily consisted of grasses and shrubs (Figure 4.5).

Figure 4.5 View of Intermittent Portion of Watercourse A Adjacent to Agricultural Field, Facing South

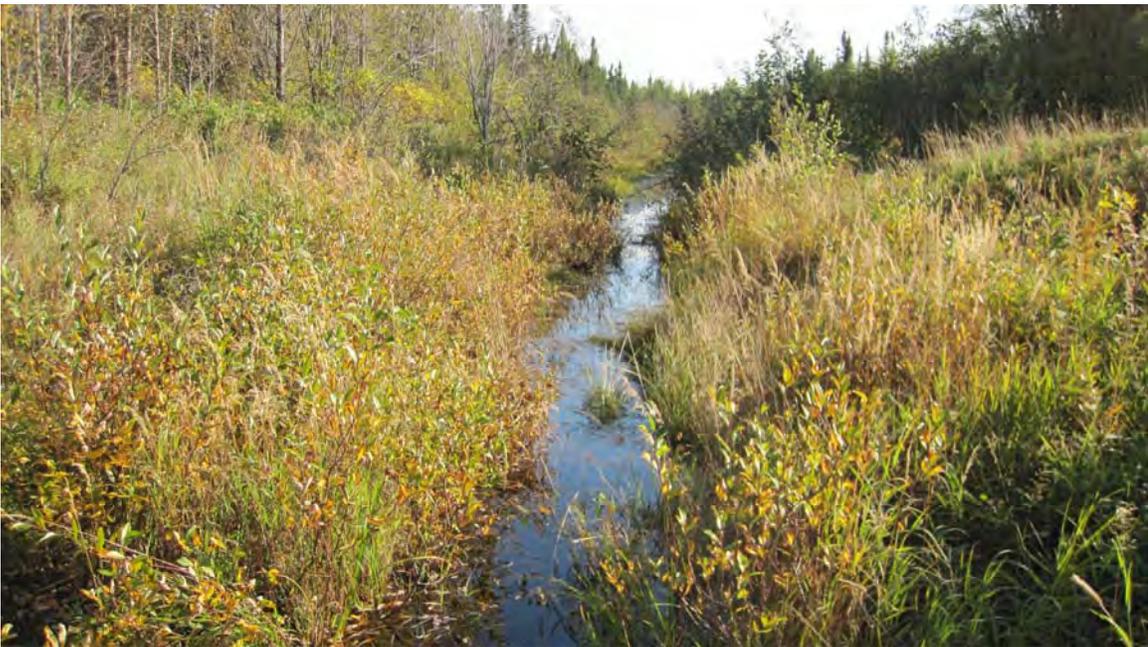
The large banks along the channel taper off slightly as it extends south, and level off at the site of an old water crossing situated approximately 100 m north of the south-western woodland on the Project Location (Figure 1.1). The water crossing did not appear to be maintained, and was likely used for agricultural purposes in the past. No culvert was found at this site, however, the presence of cobble stones was noted. Watercourse A transitions from an intermittent stream to a permanent stream as it extends south into the thicket and woodland to the south (Figure 4.6). In this location, channel width is approximately 2 m wide and 1 m high. The average annual high water mark was found to be the top of the bank. Standing water was present at depths of 10 to 30 cm with muck bottom. No visible flow was present. In-stream vegetation consisted of grasses, and riparian vegetation consisted of grasses and shrubs.

Figure 4.6 View of Watercourse A as it Transitions from an Intermittent Stream to a Permanent Stream, Facing South

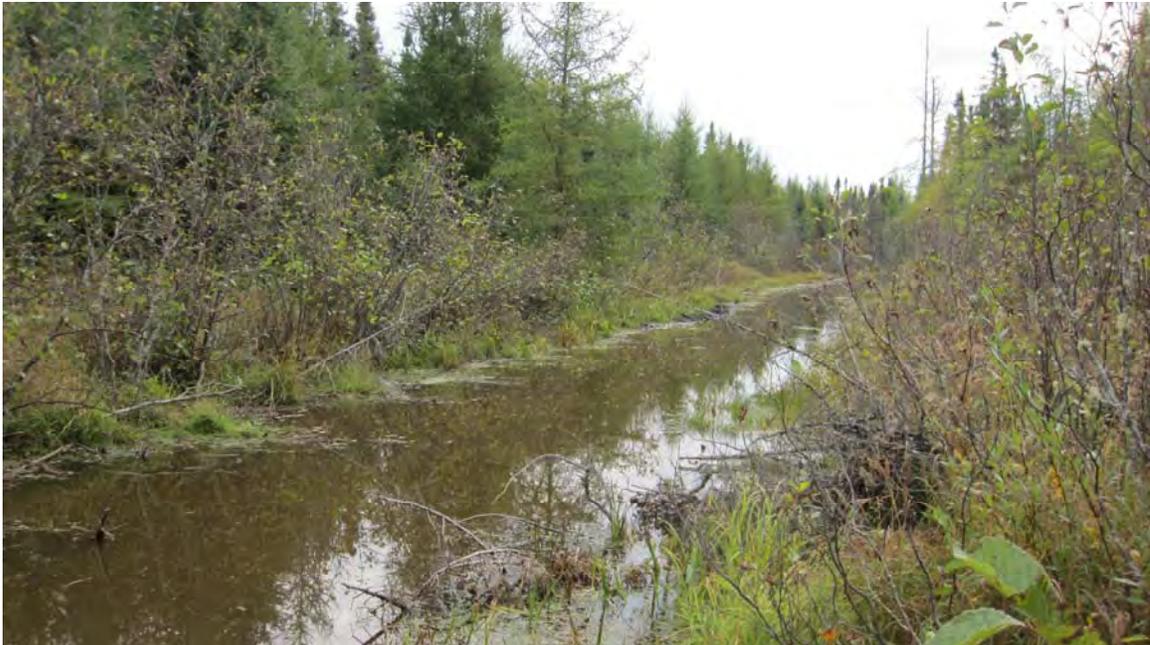
Watercourse A extends south into dense thicket and woodland as a permanent stream for approximately 300 m (Figure 1.1). The channel width and average annual high water mark increases to approximately 4 m, up to a maximum of 6 m, along this stretch – with about 0.5 m high banks. Water depths along this portion of the permanent stream ranged from approximately 0.5 to 1 m, with muck bottom. No visible flow was observed. Riparian vegetation included grasses, shrubs and trees (Figure 4.7). This section of Watercourse A was assessed as potential fish/turtle habitat.

Figure 4.7 View of Watercourse A as it Extends South Through the Woodland

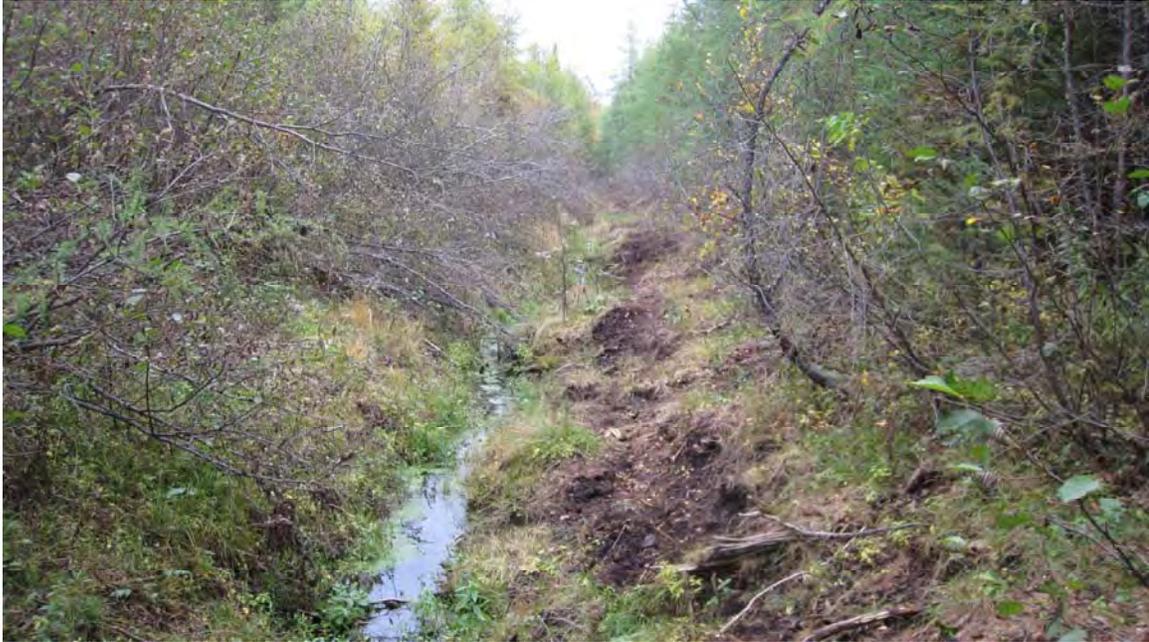
The presence of beavers in the area was noted, as evidenced by the large amount of felled trees and gnawed stumps; as well as a beaver lodge and two separate dams located along the permanent stream section of Watercourse A. The first beaver dam was encountered just after the stream makes an almost ninety degree bend west (Figure 1.1). The permanent stream continues to extend westward through the woodland after this first beaver dam, with the same overall characteristics. The second beaver dam was encountered approximately 100 m west of the first beaver dam (Figure 4.1). This dam, for the most part, fully halts a large proportion of the permanent stream. The watercourse channel drops off considerably after this dam, and continues westward in a narrower channel with steeper banks (i.e., 1.5 m wide and 1.5 m high) (Figure 4.8). The average annual high water mark was deemed to be the top of the bank, approximately 4 m wide all the way across. Water depths were reduced to approximately 10 cm along this shallow section of the permanent stream, with muck bottom. No visible flow was present within the channel during the time of the site investigation. Riparian vegetation remains consistent with the woodland species present. Several large burrows of approximately 30 to 50 cm in diameter were noted along the steep banks of this portion of Watercourse A. Watercourse A continues to extend westwards off of the Project Location and past 120 m in this shallow, creek-like fashion.

Figure 4.8 View of Watercourse A Facing West as it Drops Off Following the Second Beaver Dam
