Abitibi Solar Project

Water Body Site Investigations Report

H334844-0000-07-124-0247

October 18, 2012

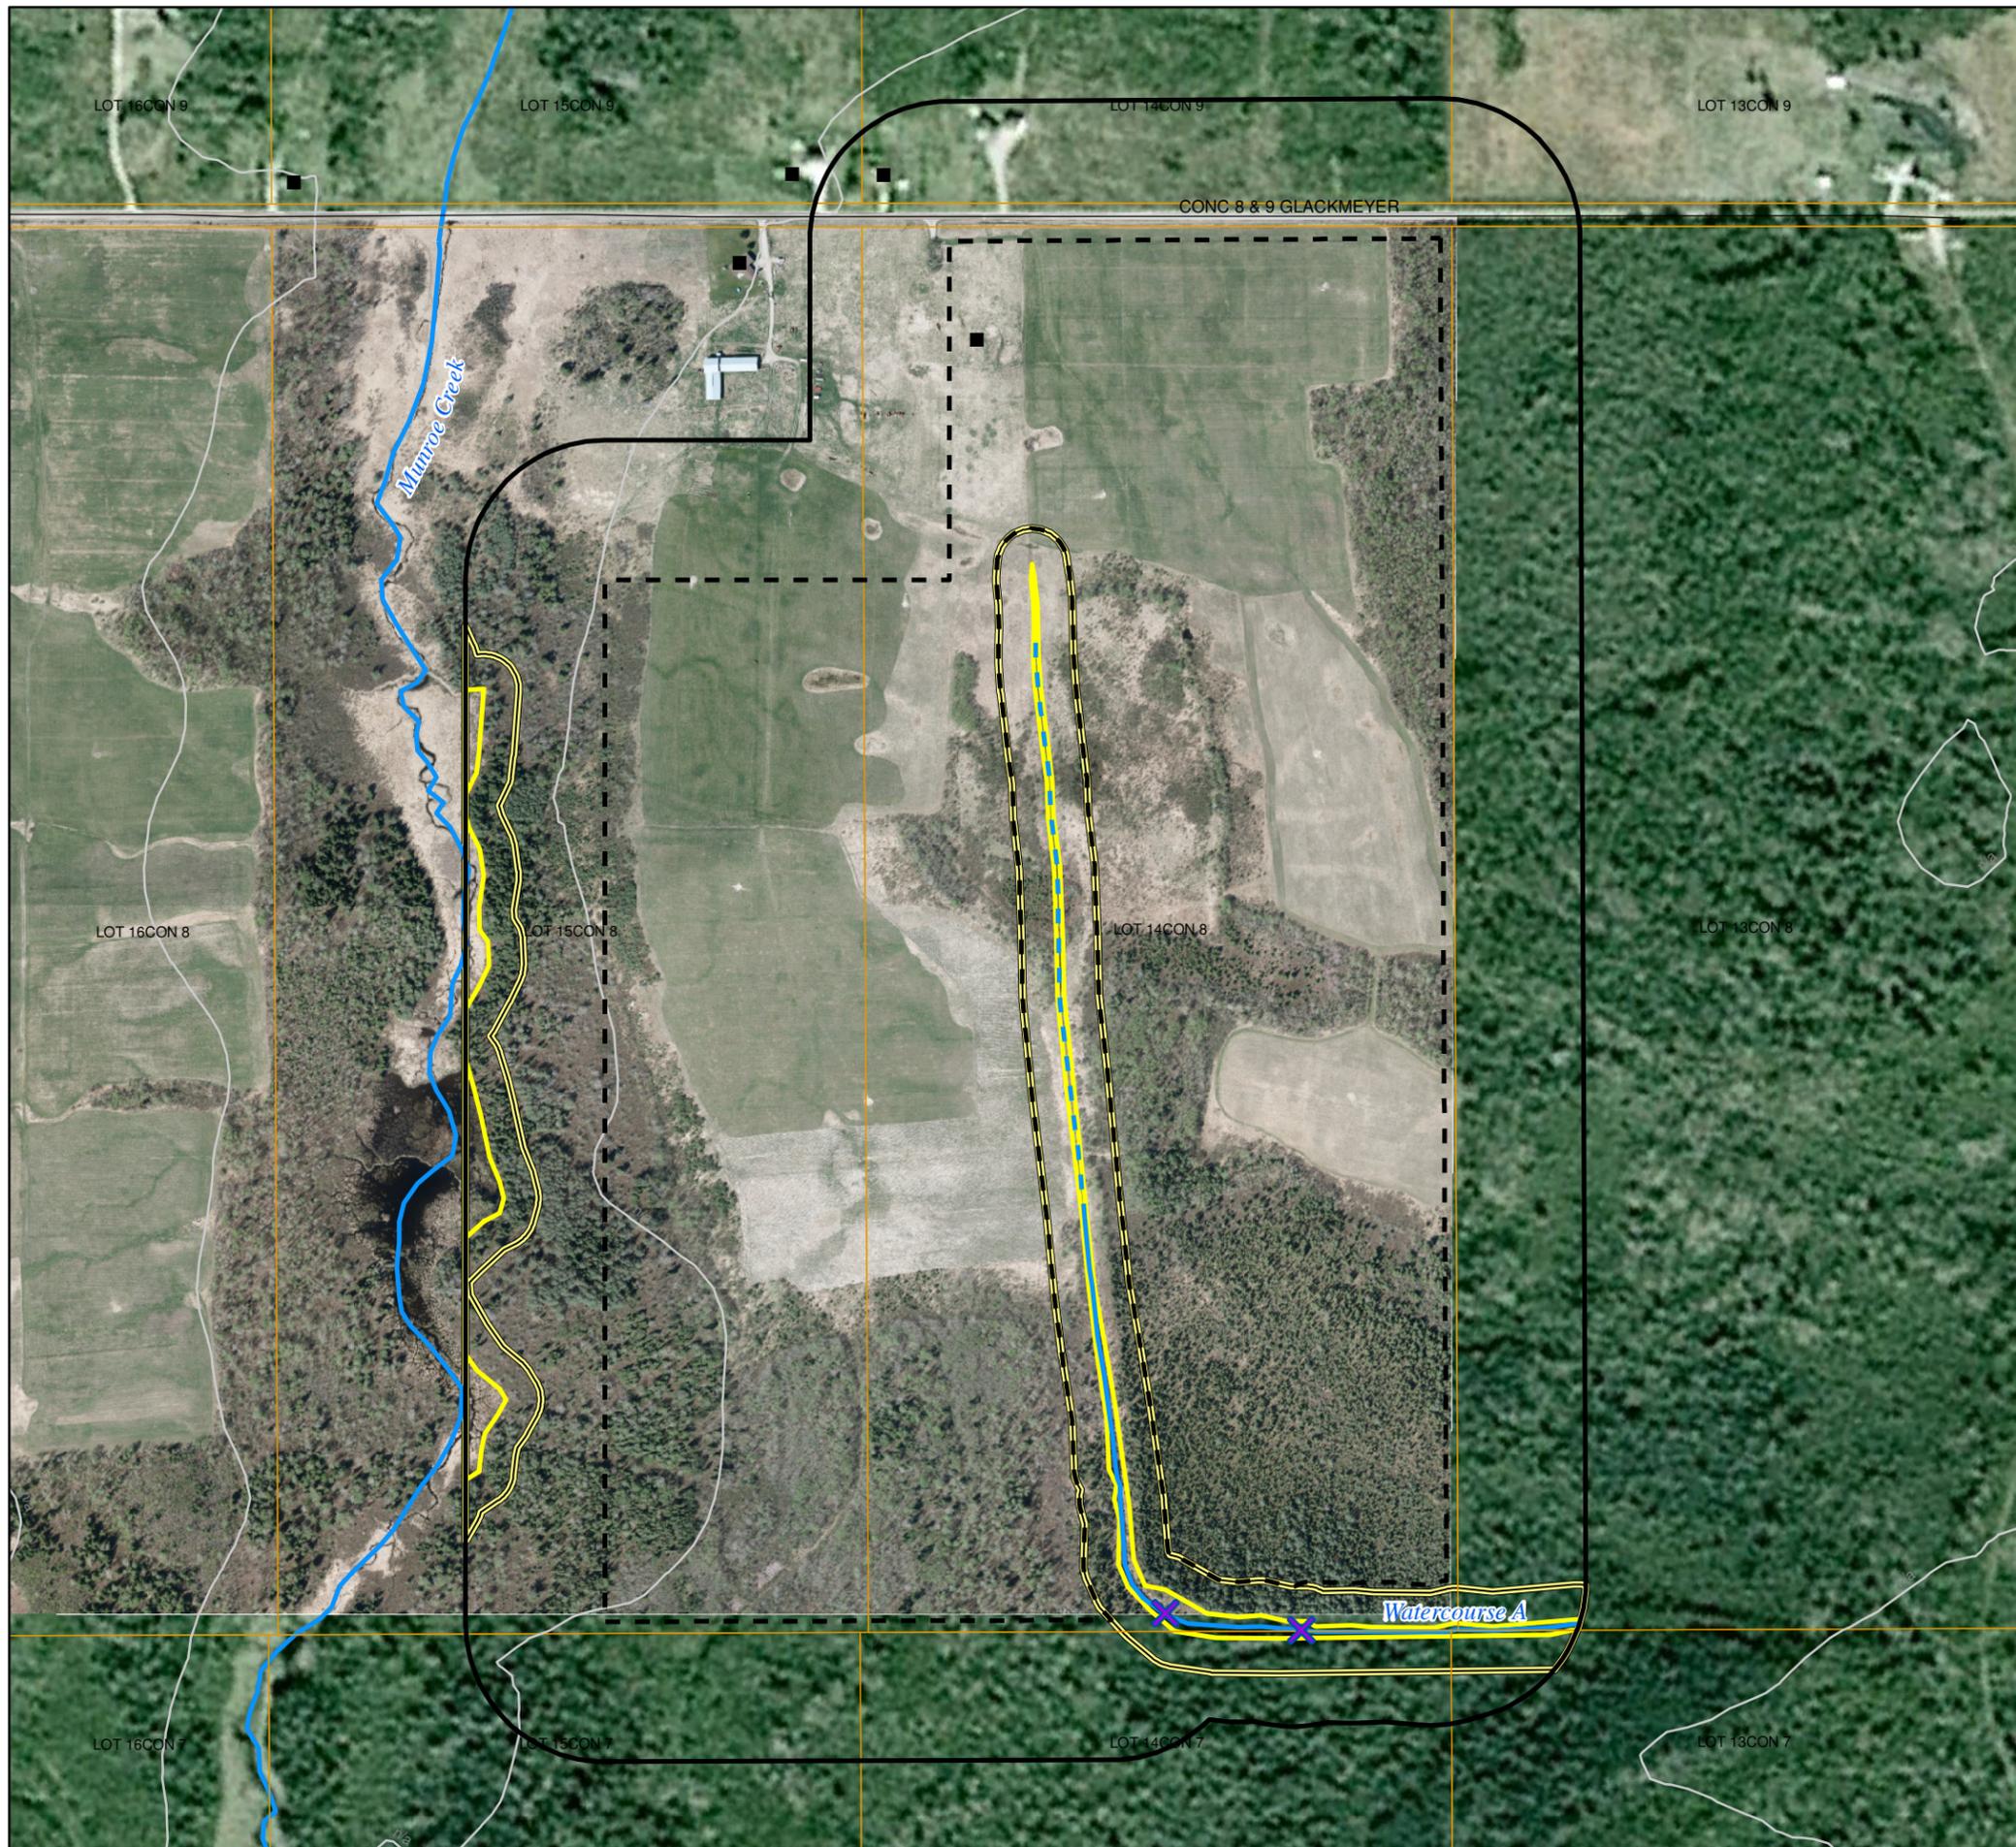
Figure 1.1
 Northland Power Inc.
Abitibi Solar Project
Water Body Site
Investigation Results

As shown in Figure 1.1 and summarized in Table 5.1, the solar panel Project Location is located between 30 and 120 m from the average annual high water mark of Watercourse A and Munroe Creek. The proposed access road and connection line to adjoining solar facility will cross Munroe Creek. In addition, the proposed transmission line Project location will cross or run within 120 m of approximately 38 waterbodies, depending on the final route selected. As a result, a *Water Body Environmental Impact Study* is required and will be prepared to address potential negative environmental effects to the identified water body features associated with the proposed development. Recommendations on mitigation measures will be provided to ensure the long-term ecological health and integrity of these water body features.

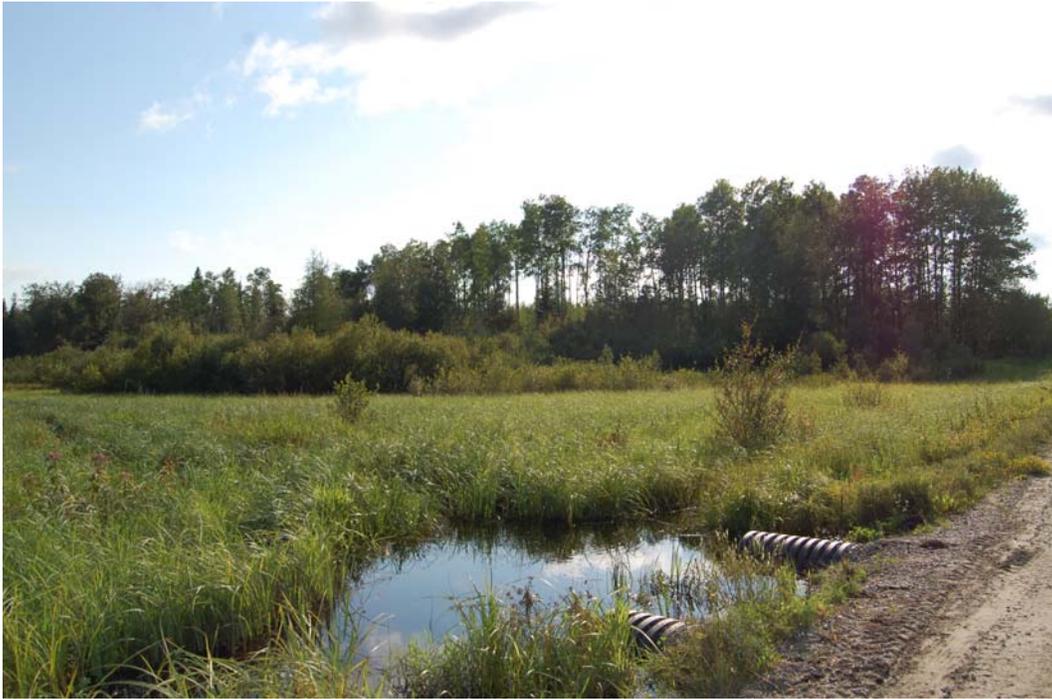
Figure 4.1 View of Munroe Creek from the South Side of Glackmeyer Concession Road 9

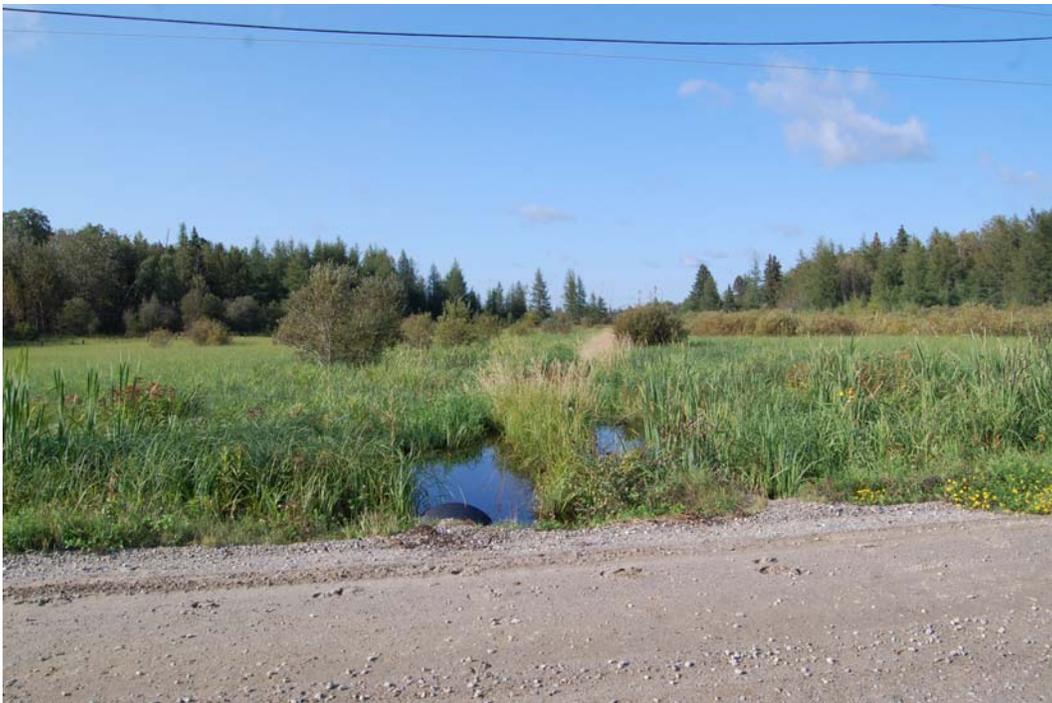
Figure 4.2 View of Munroe Creek from the North Side of Glackmeyer Concession Road 9

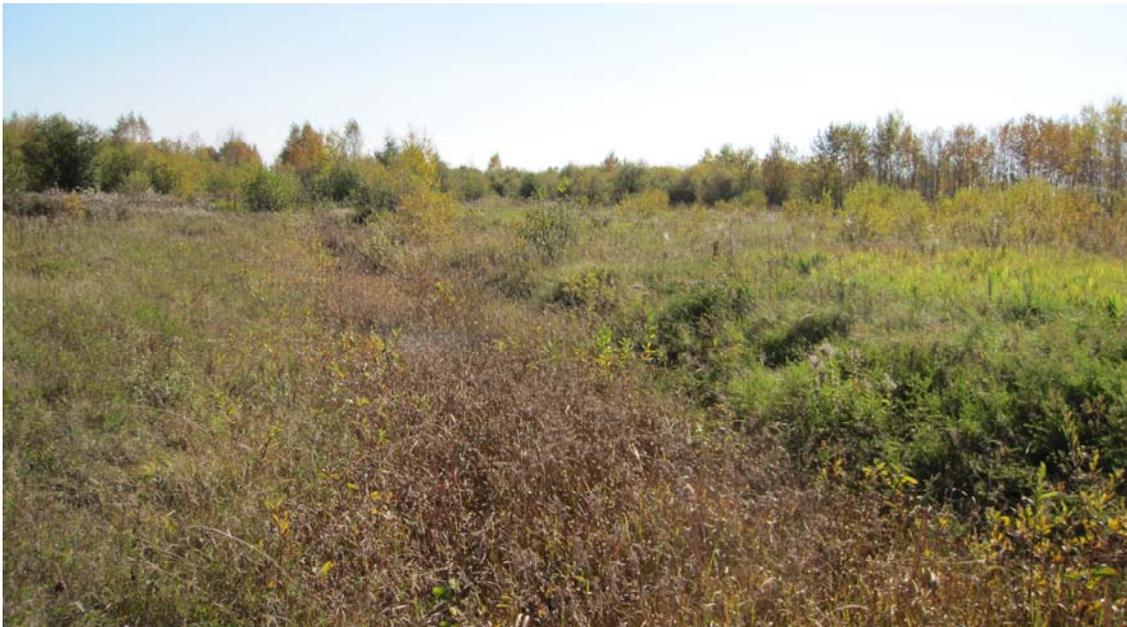
Watercourse A is both an intermittent and permanent stream that originates in an agricultural field on the north-central portion of the property on which the Project is located (Figure 1.1). The intermittent reach of Watercourse A occurs at its point of origin and continues south for approximately 100 m (Figure 4.3). This 100 m reach has a channel-width of approximately 3 m, with 1.5 m high banks. The average annual high watermark was determined to be top of bank. Although highly variable, standing water was noted in several areas, and ranged from approximately < 1 to 10 cm in depth, with a muck bottom. No flowing water was present along this stretch of Watercourse A. The channel was found to contain water-favouring wetland meadow species such as cattails, sedges, rushes and grasses. Riparian vegetation consisted of mainly grasses and small shrubs (Figure 4.3).

Figure 4.3 View of the Initial, Intermittent Stream Portion of Watercourse A, Facing South

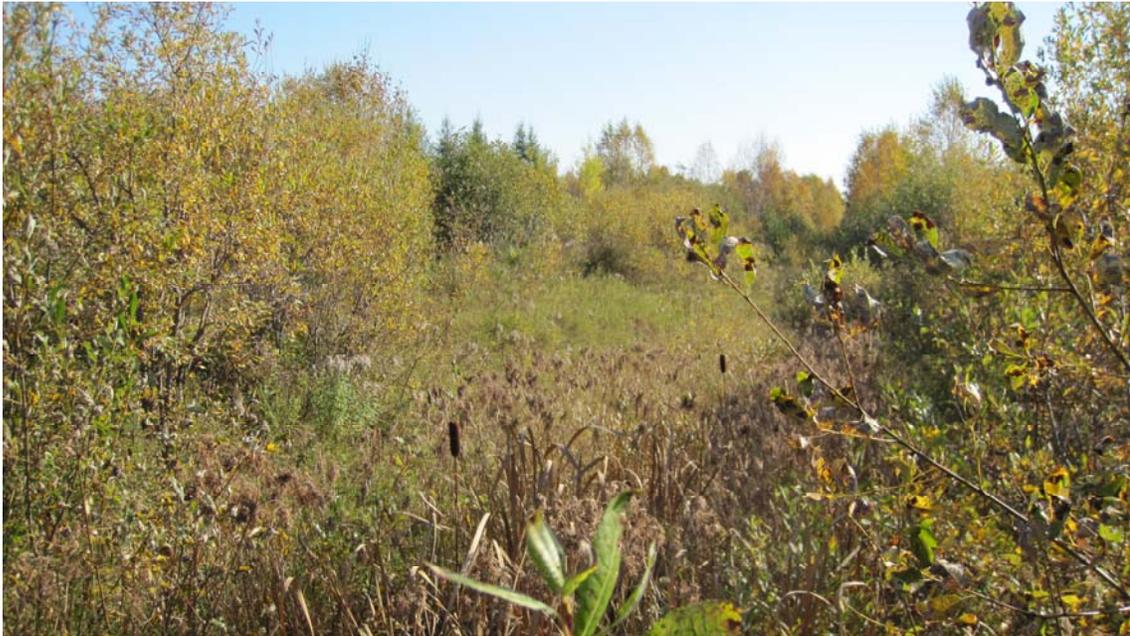
As Watercourse A extends in a southern direction near the central portion of the Project Location, it enters a thicket area of dense in-stream and riparian vegetation for approximately 200 m (Figure 1.1). In this area, the watercourse continues to exist as an intermittent stream, with a channel width of approximately 4 to 6 m and gradually sloping, 2 m high banks. The average annual high water mark was determined to be approximately 10 to 12 m across from bank to bank. Standing water was highly absent, but was present in several areas at depths ranging from approximately < 1 cm to 10 cm, with leafy/muck bottom. No flowing water was present along this stretch of the channel. In-stream vegetation ranged from water-favouring species such as cattails and sedges, and small trees/thick shrubs and bushes, such as alders, willows and dogwoods (Figure 4.4).

Figure 4.4 View of Intermittent Stream Portion of Watercourse A as it Passes through Dense Thicket, Facing South

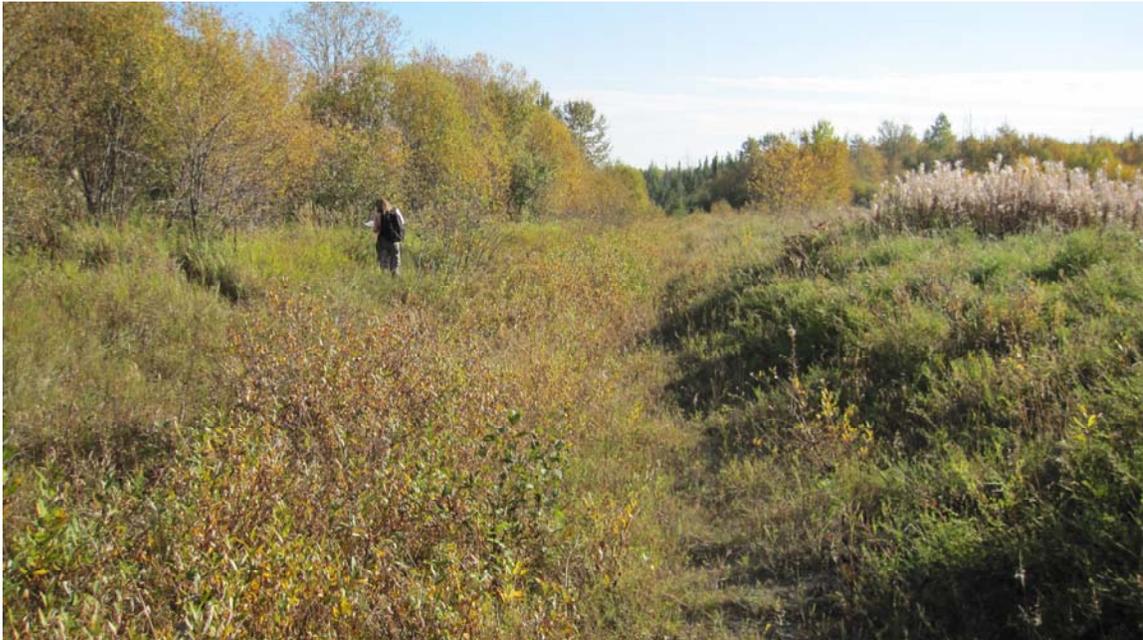
After passing through dense thicket, Watercourse A continues to exist as an intermittent stream, and extends southward next to an agricultural field that is situated to the west (Figure 1.1). During this stretch, the channel width increases to approximately 7 to 10 m width, with relatively large, steep banks approximately 2 to 2.5 m high. The average annual high water mark was assessed to be just below the top of the 7 to 10 m wide banks. No standing water was present along this 200 m stretch of Watercourse A during the time of the site investigations. Riparian and in-stream vegetation primarily consisted of grasses and shrubs (Figure 4.5).

Figure 4.5 View of Intermittent Portion of Watercourse A
Adjacent to Agricultural Field, Facing South

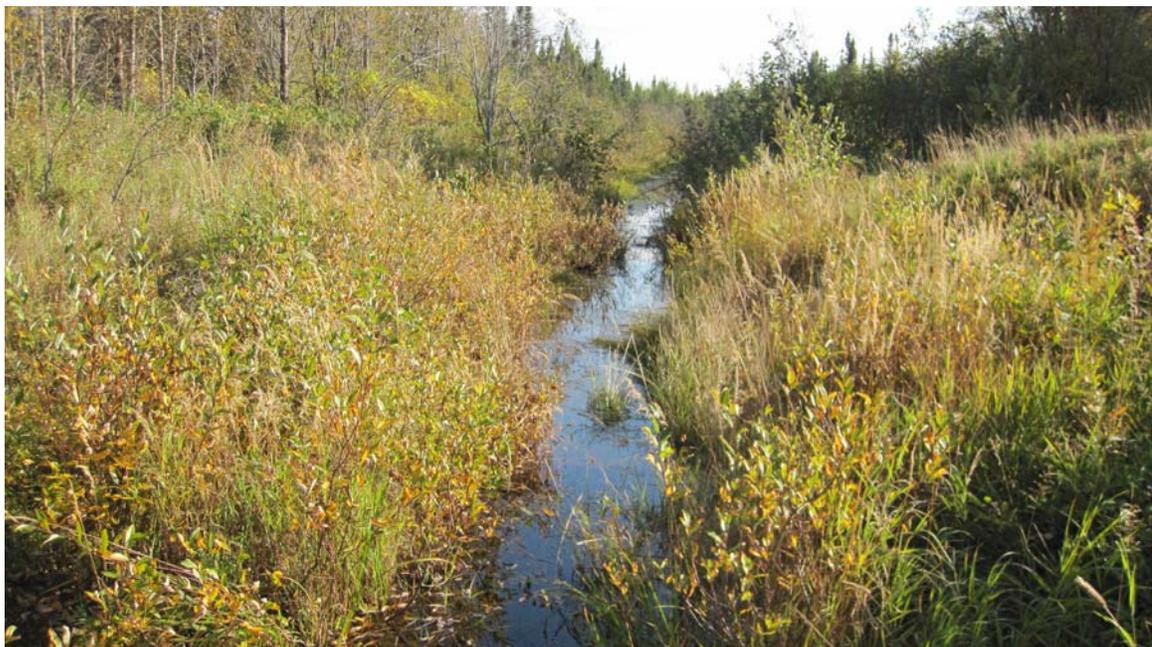
The large banks along the channel taper off slightly as it extends south, and level off at the site of an old water crossing situated approximately 100 m north of the south-western woodland on the Project Location (Figure 1.1). The water crossing did not appear to be maintained, and was likely used for agricultural purposes in the past. No culvert was found at this site, however, the presence of cobble stones was noted. Watercourse A transitions from an intermittent stream to a permanent stream as it extends south into the thicket and woodland to the south (Figure 4.6). In this location, channel width is approximately 2 m wide and 1 m high. The average annual high water mark was found to be the top of the bank. Standing water was present at depths of 10 to 30 cm with muck bottom. No visible flow was present. In-stream vegetation consisted of grasses, and riparian vegetation consisted of grasses and shrubs.

Figure 4.6 View of Watercourse A as it Transitions from an Intermittent
Stream to a Permanent Stream, Facing South

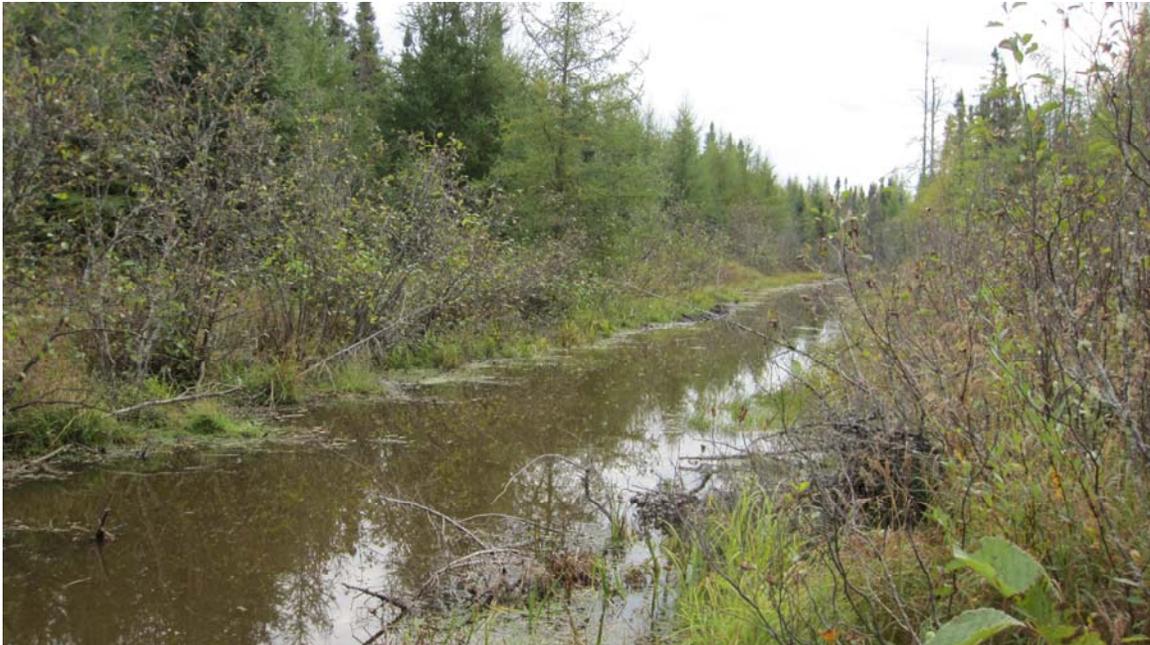
Watercourse A extends south into dense thicket and woodland as a permanent stream for approximately 300 m (Figure 1.1). The channel width and average annual high water mark increases to approximately 4 m, up to a maximum of 6 m, along this stretch – with about 0.5 m high banks. Water depths along this portion of the permanent stream ranged from approximately 0.5 to 1 m, with muck bottom. No visible flow was observed. Riparian vegetation included grasses, shrubs and trees (Figure 4.7). This section of Watercourse A was assessed as potential fish/turtle habitat.

Figure 4.7 View of Watercourse A as it Extends South Through the Woodland

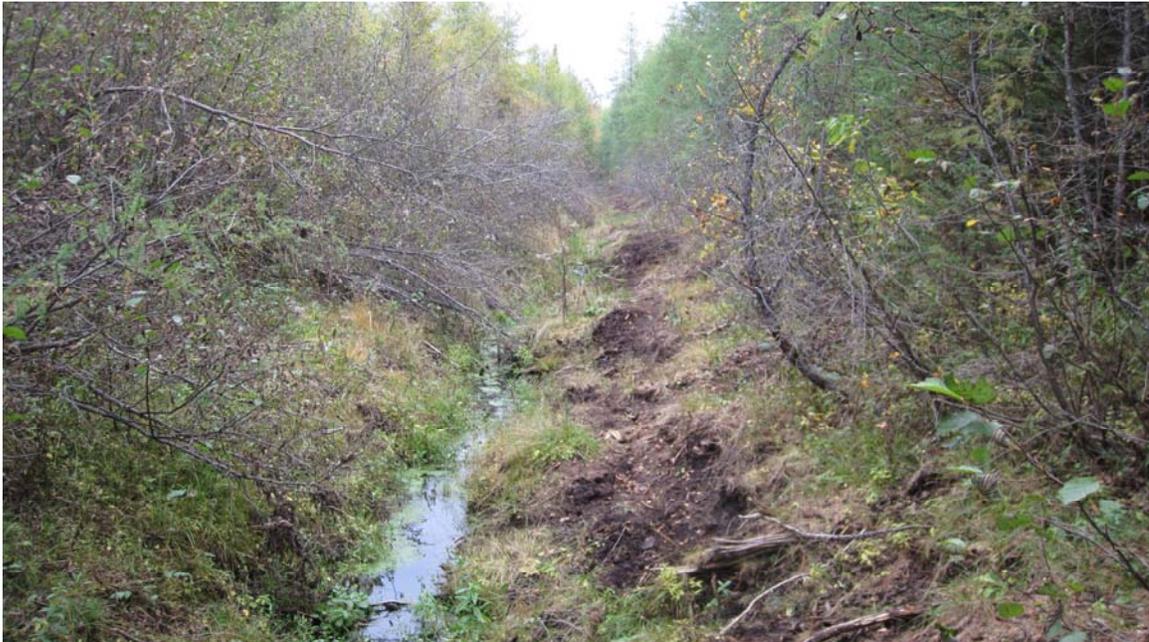
The presence of beavers in the area was noted, as evidenced by the large amount of felled trees and gnawed stumps; as well as a beaver lodge and two separate dams located along the permanent stream section of Watercourse A. The first beaver dam was encountered just after the stream makes an almost ninety degree bend west (Figure 1.1). The permanent stream continues to extend westward through the woodland after this first beaver dam, with the same overall characteristics. The second beaver dam was encountered approximately 100 m west of the first beaver dam (Figure 4.1). This dam, for the most part, fully halts a large proportion of the permanent stream. The watercourse channel drops off considerably after this dam, and continues westward in a narrower channel with steeper banks (i.e., 1.5 m wide and 1.5 m high) (Figure 4.8). The average annual high water mark was deemed to be the top of the bank, approximately 4 m wide all the way across. Water depths were reduced to approximately 10 cm along this shallow section of the permanent stream, with muck bottom. No visible flow was present within the channel during the time of the site investigation. Riparian vegetation remains consistent with the woodland species present. Several large burrows of approximately 30 to 50 cm in diameter were noted along the steep banks of this portion of Watercourse A. Watercourse A continues to extend westwards off of the Project Location and past 120 m in this shallow, creek-like fashion.

Figure 4.8 View of Watercourse A Facing West as it Drops Off Following the Second Beaver Dam
