# Martin's Meadows Solar Project

## Draft Water Body Site Investigation Report

April 27, 2012

H334844-0000-07-124-0324

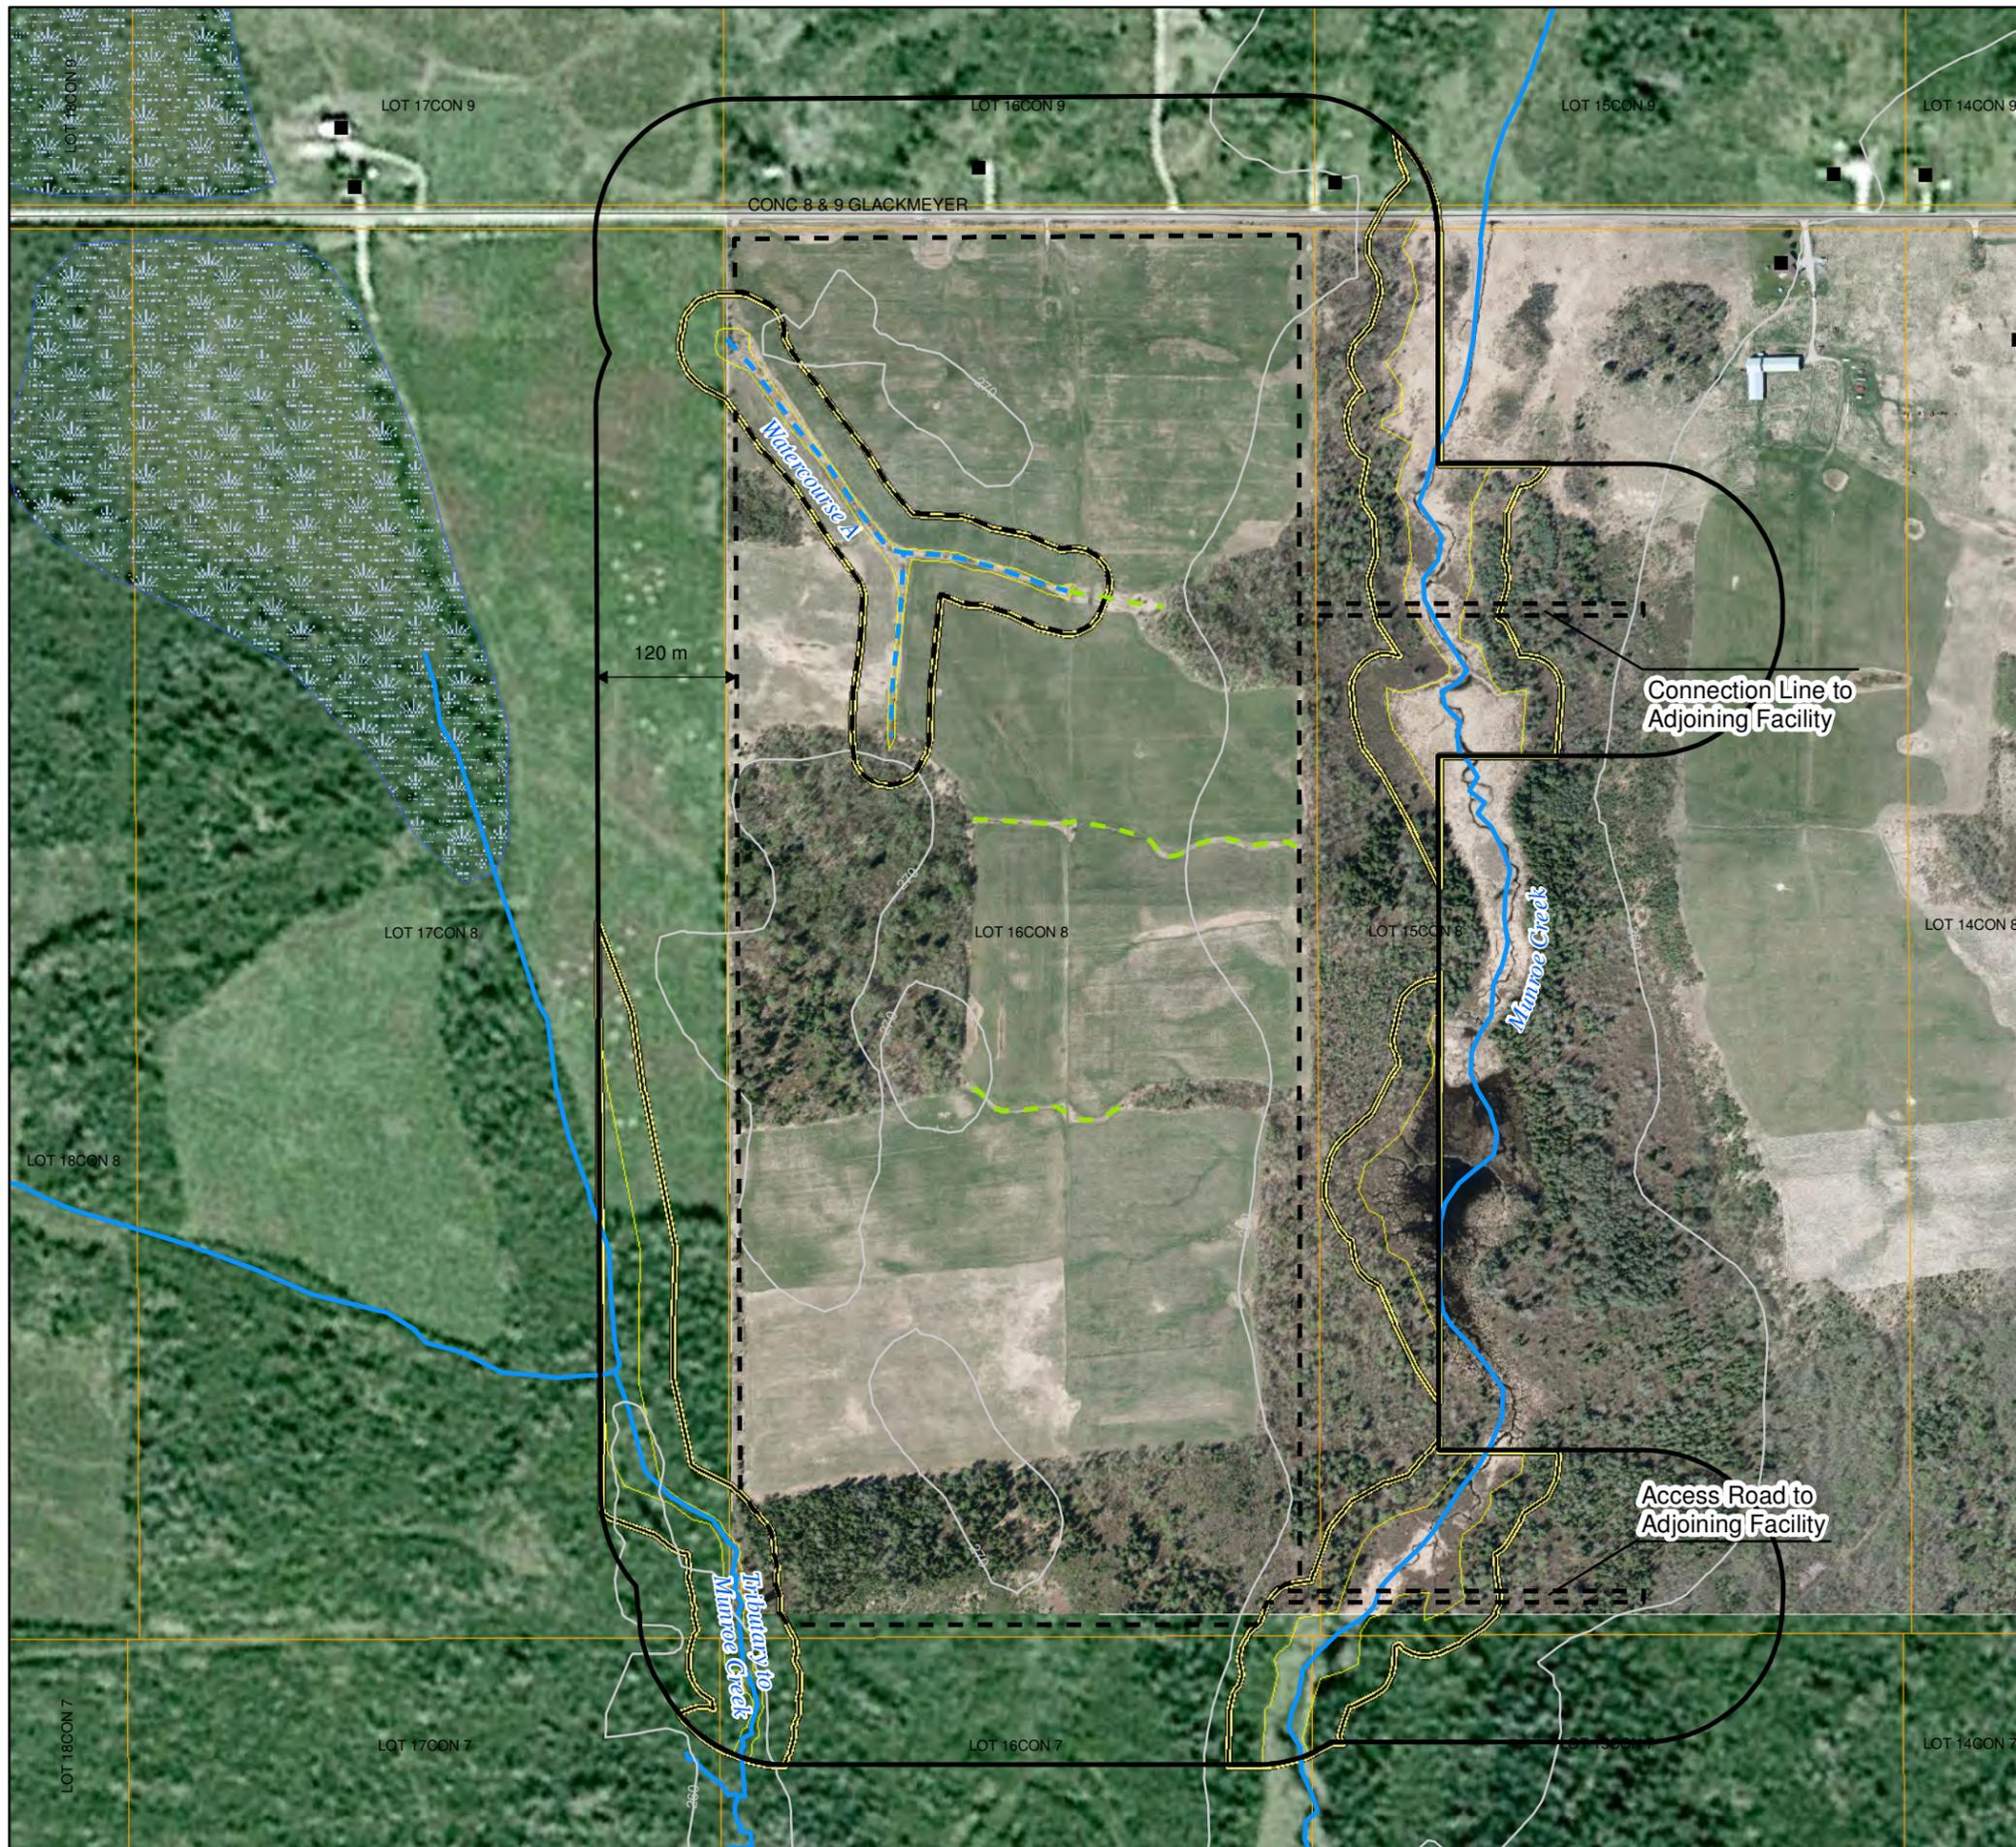
Figure 1.1  
 Northland Power Inc.  
**Martin's Meadows Solar Project**  
 Water Body Site  
 Investigation Results **HATCH**

In addition, a watercourse not previously identified during the records review (hereinafter referred to as Watercourse A) was discovered on the northeast portion of the Project Location (Figure 1.1). An assessment of Watercourse A is also been provided in the following sections. Several other grassed swales, which do not meet the definition of a water body per the REA Regulation, were observed during the site investigation (Figure 1.1). These are also described in the following sections.

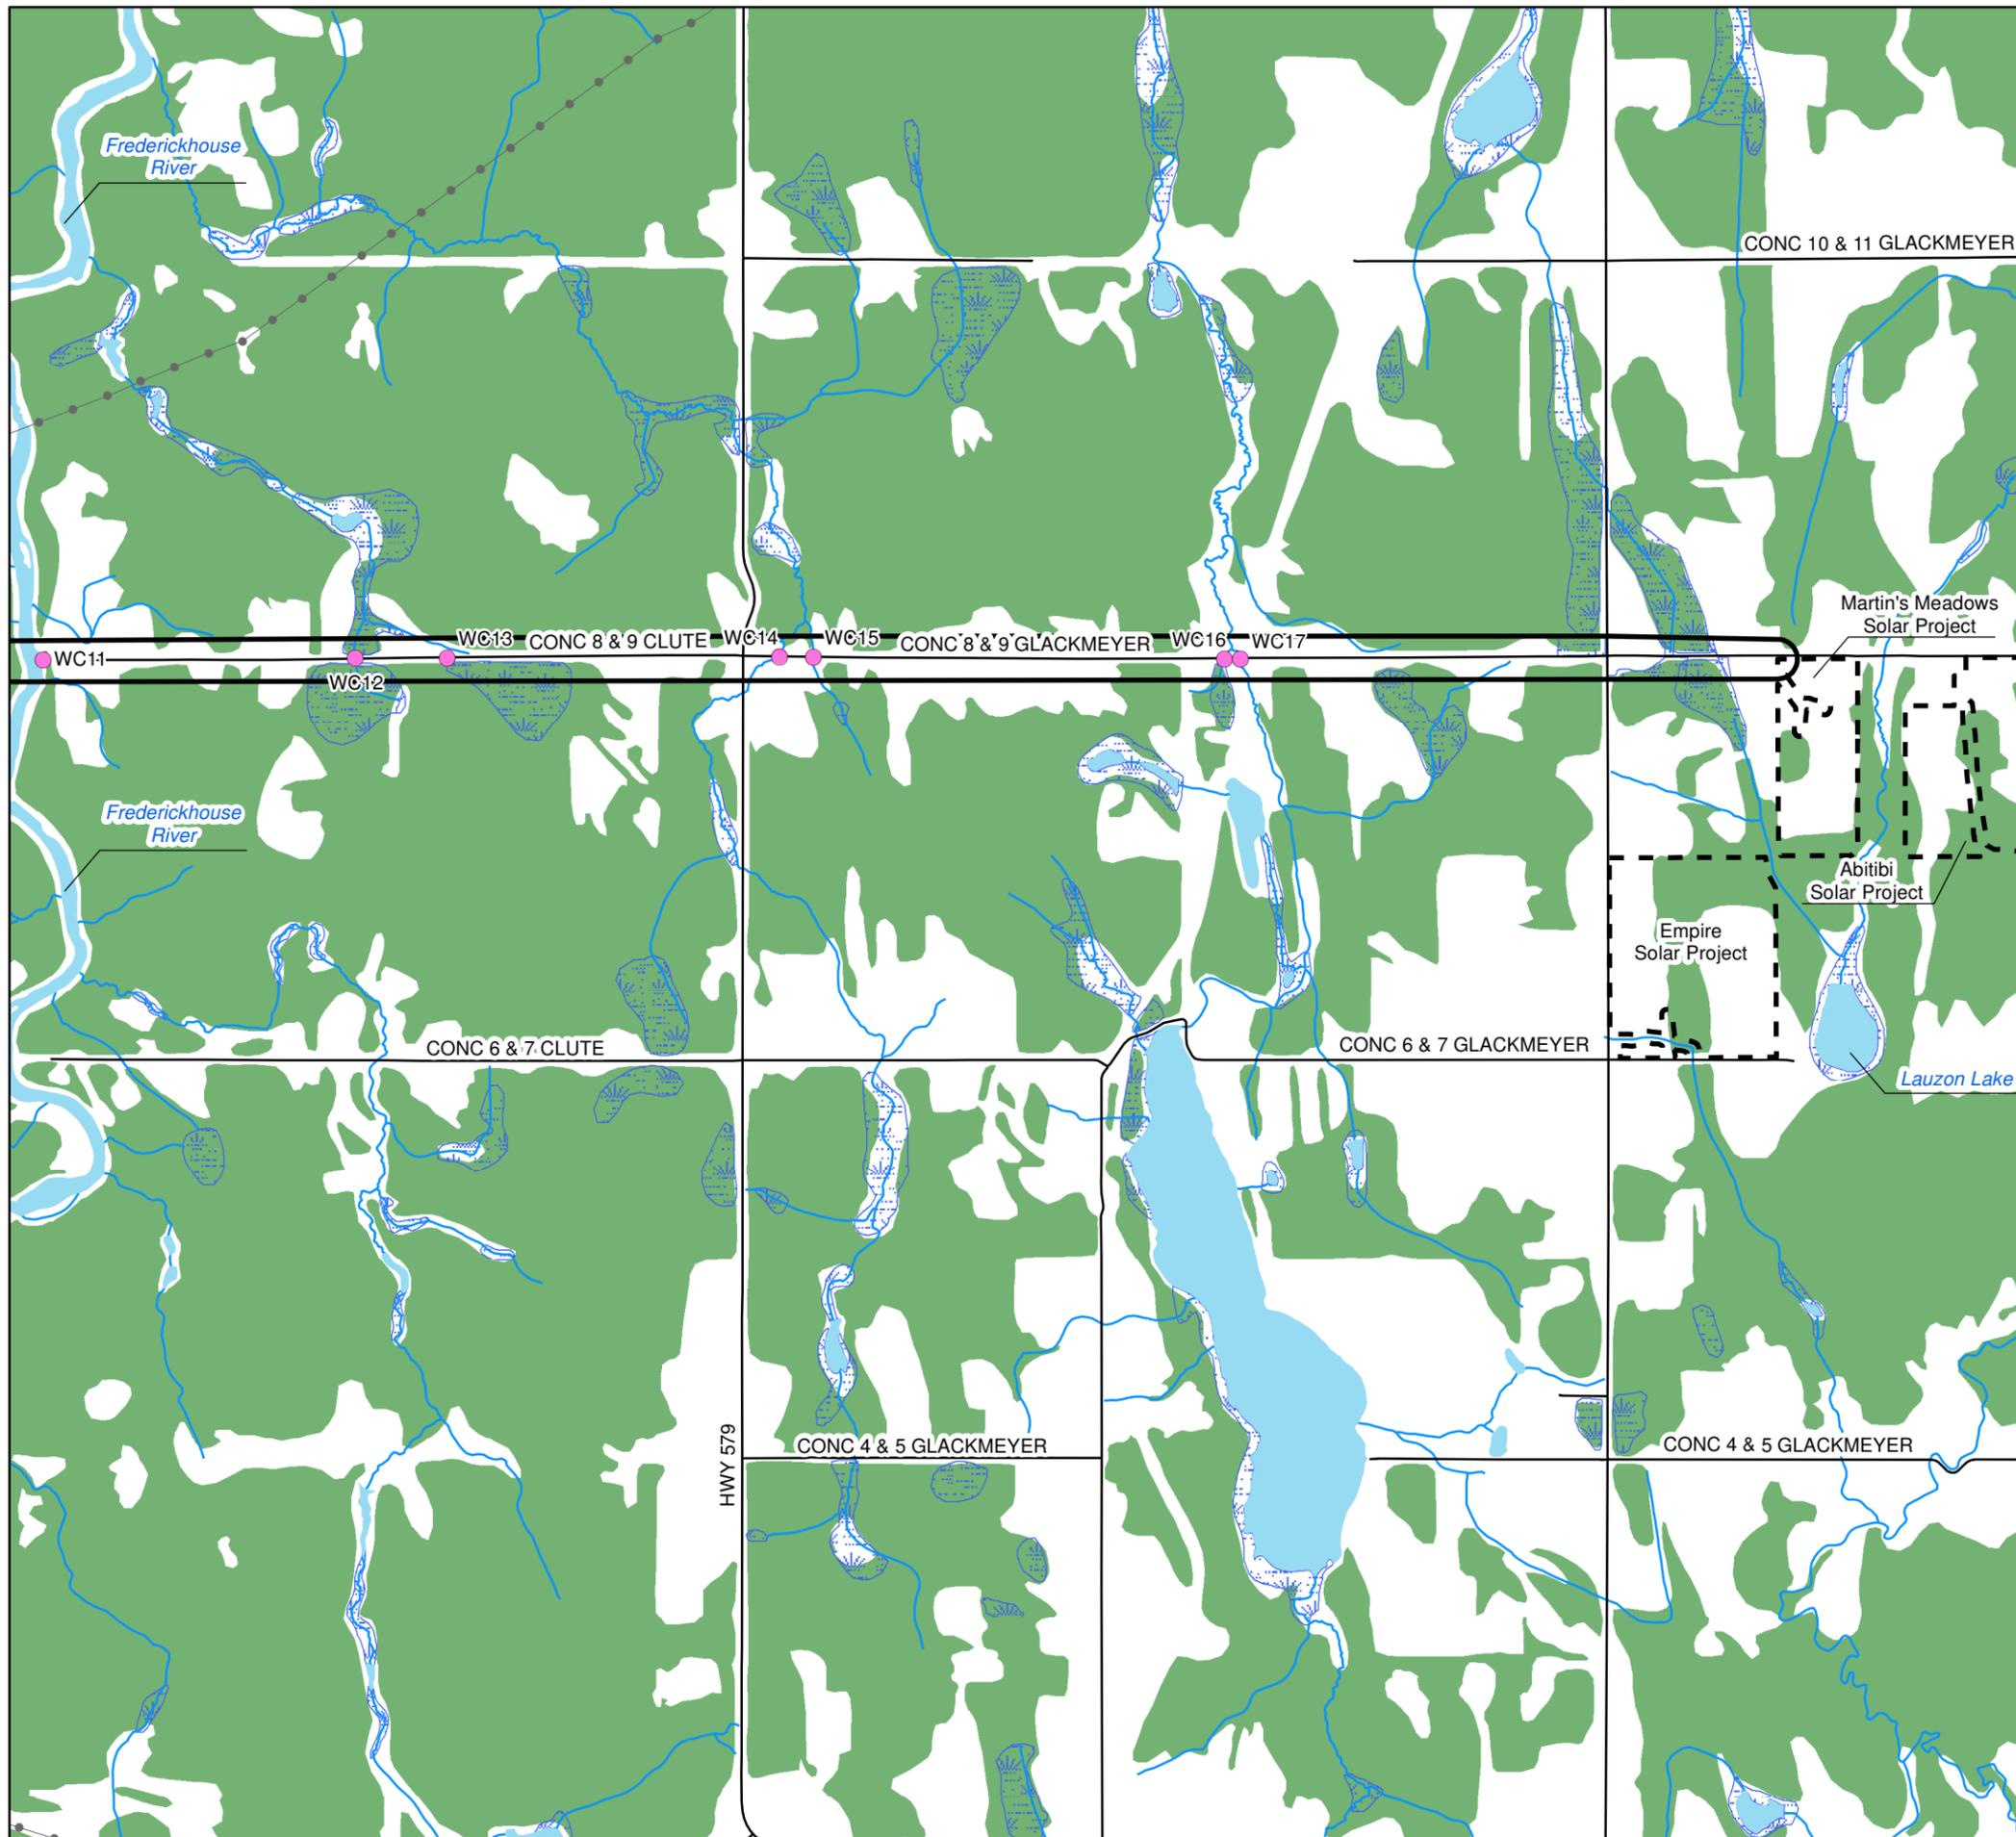
Figure 1.2  
 Northland Power Inc.  
**Distribution Line Project Location  
 (Eastern Half) - Waterbody  
 Site Investigation Results**

A total of 38 waterbodies were observed along the distribution line route options, as shown in Figures 1.2 and 1.3, and summarized in Table 4.1, which presents the watercourse identifier (as labelled on Figures 1.2 and 1.3), summary of watercourse observations (watercourse type, average width and depth, substrate, bank vegetation and other observations). There were 36 unnamed watercourses, the Frederickhouse River and Deception Creek. In addition, the proposed distribution line will pass within 120 m of Lower Deception Lake.

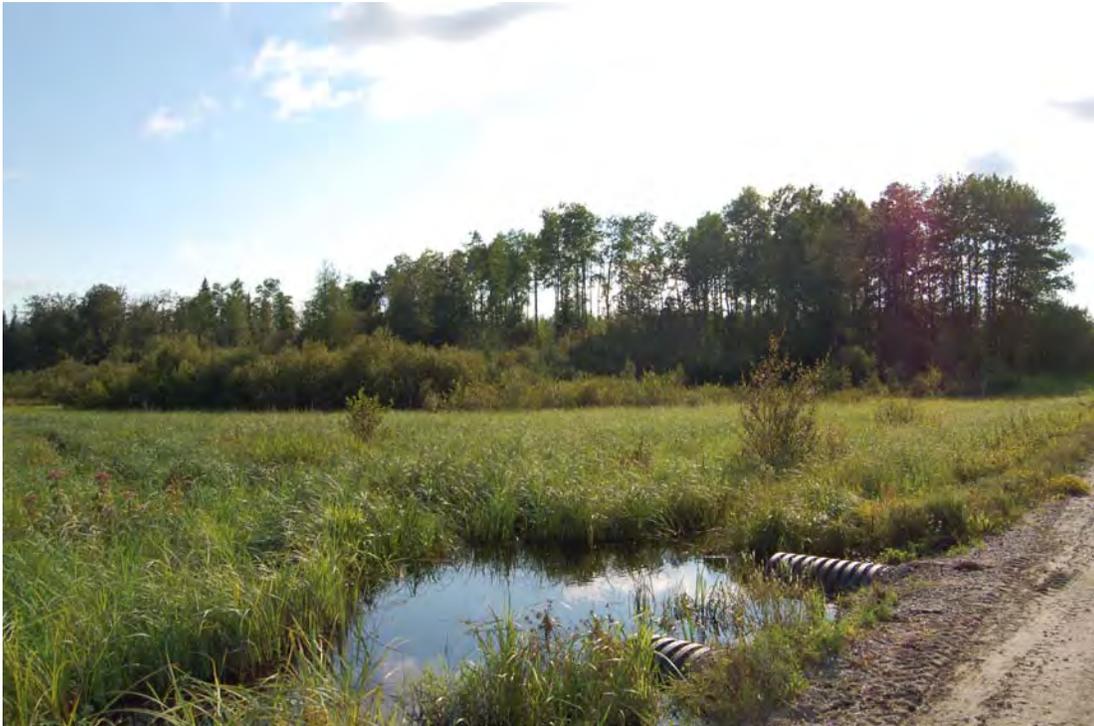
During the site investigations, the presence of Munroe Creek was confirmed, and it was determined to be a permanent stream. Munroe Creek flows in a relatively wide, low lying valley, with abundant wetland vegetation, surrounding by wooded areas adjacent to the agricultural fields on the adjacent properties. This wetland is comprised of emergent vegetation and dominated by broadleaved cattails, grasses and sedges. The meadow marsh type wetland is bordered by a shrub thicket swamp

dominated will willow and dogwood species. Beaver activity is evident at several locations along the creek, with several dams creating online ponds. In these areas, the average annual high water mark is > 100 m across. In other areas not affected by beaver activity, the average annual high water mark is approximately 30 m across, due to the meadow vegetation surrounding the main creek channel. A photograph of the wetland area of Munroe Creek, adjacent to the road is shown in Figures 4.1 and Figure 4.2.

**Figure 4.1 View of Munroe Creek from the South Side of Glackmeyer Concession Road 9**

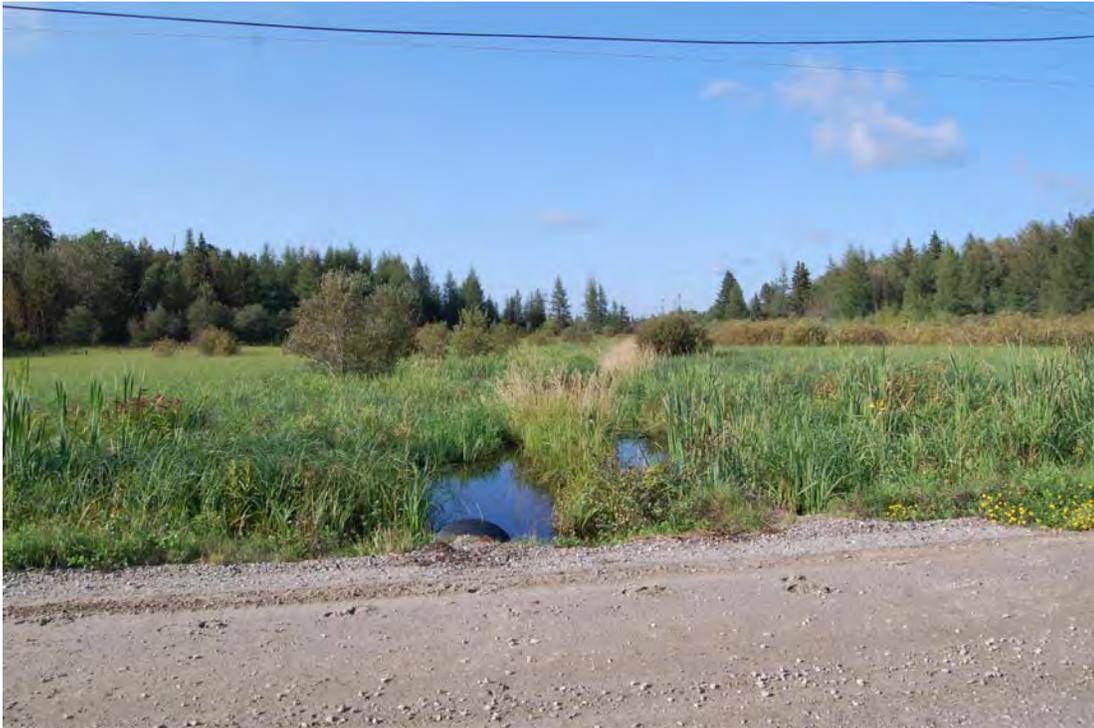
**Figure 4.2 View of Munroe Creek from the North Side of Glackmeyer Concession Road 9**

Munroe Creek meets the definition of a water body, as outlined in the REA Regulation (Section 1.2). The average annual high water mark of Munroe Creek would be located a minimum distance of 30 m from the solar panel Project location. However, it would be crossed by the proposed access road and connection lines to the adjoining solar facility (Figure 1.1). Therefore, an EIS will be required to assess the potential negative effects of the Project on the creek and lands within 30 m of the average annual high water mark.

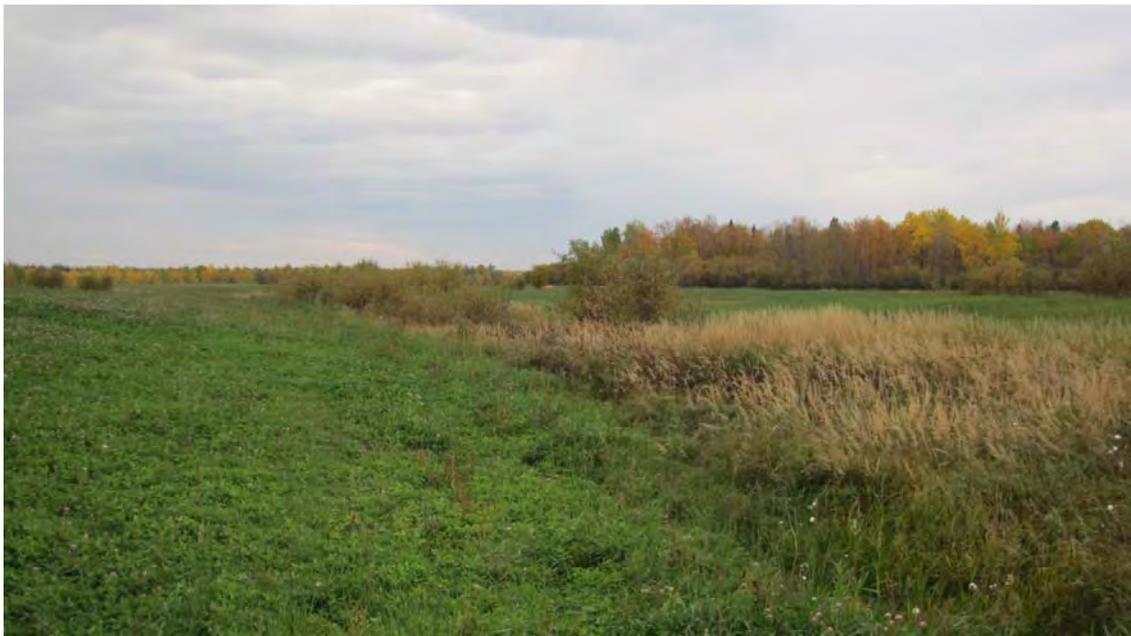
The presence of Watercourse A, an intermittent stream, was confirmed during the site investigations. Watercourse A occurs on the northwestern portion of the Project Location. It appears to be a man-made ditch that utilizes the natural contours of the land to help facilitate surface water drainage from the adjacent agricultural fields (Figure 4.3). It was determined to be an intermittent stream that likely receives flow after heavy precipitation events, and is dry the remaining months of the year. The watercourse did not appear to be connected to the municipal ditch. This watercourse has in-stream and riparian vegetation that consists of grasses, sedges, rushes and shrubs, such as small-fruited bulrush, broadleaved cattail, and scattered shrubs including alder and dogwood. The Project Location and adjacent fields appear to be actively used for hay production. The channel itself is approximately 1 to 2 m in width, with an average annual high water mark of approximately 6 m across. Watercourse A follows the property line south, before making a slight bend southeast on the Project Location (Figure 1.1).

Figure 4.3 View of Watercourse A, Facing South

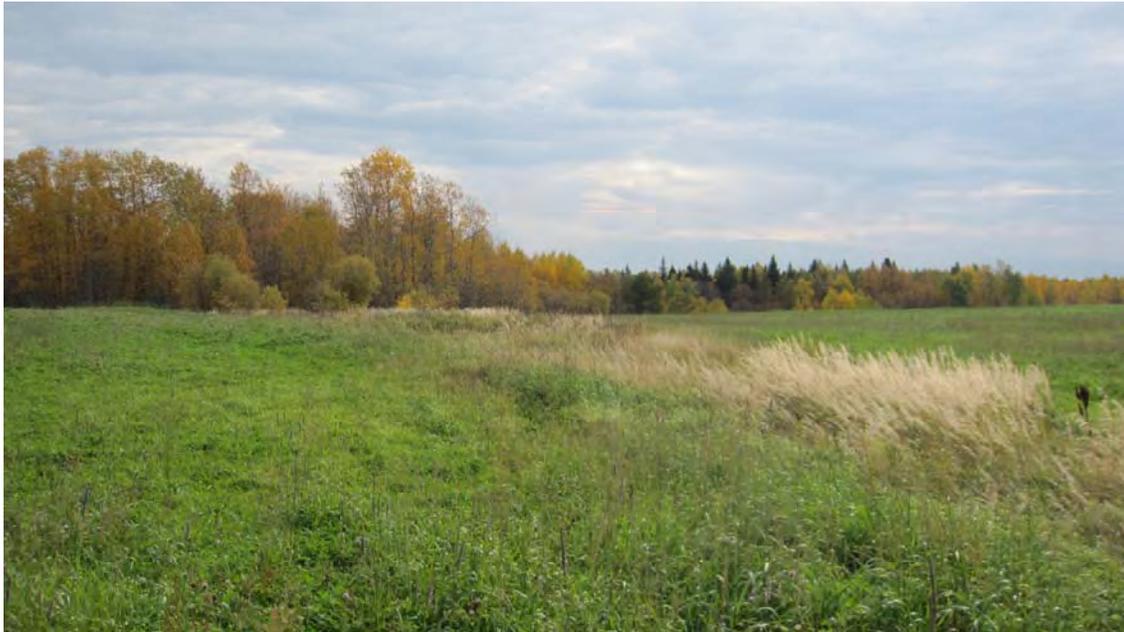
The watercourse transitions into a grassed swale (i.e., non-water body) as it extends southeast, just after it connects to a 0.5-m culvert and associated water crossing, likely used by the farmer to easily access different sides of the agricultural field (Figure 1.1). The grassed swale is relatively shallow (i.e., can be driven/tilled through), contains grassy vegetation that is not water dependant and has a width that covers a span of approximately 15 m (Figure 4.4). As such, this segment adjacent to Watercourse A was not considered an intermittent stream (or a water body feature), as per the REA regulation (Section 1.2). The grassed swale continues southeast until it dissipates into the woodland that is located on the western boundary of the Project Location (Figure 4.4).

**Figure 4.4 View of Watercourse A After Existing Farmer's Water Crossing Where it Transitions into a Grassed Swale, Facing Southeast**

The site investigation confirmed that Watercourse A is a water body feature. The proposed development area will occur within 30 to 120 m of the average annual high water mark of Watercourse A (Figure 1.1). Therefore, an EIS will be required to assess the potential negative effects of the Project on the creek and lands within 30 m of the average annual high water mark.

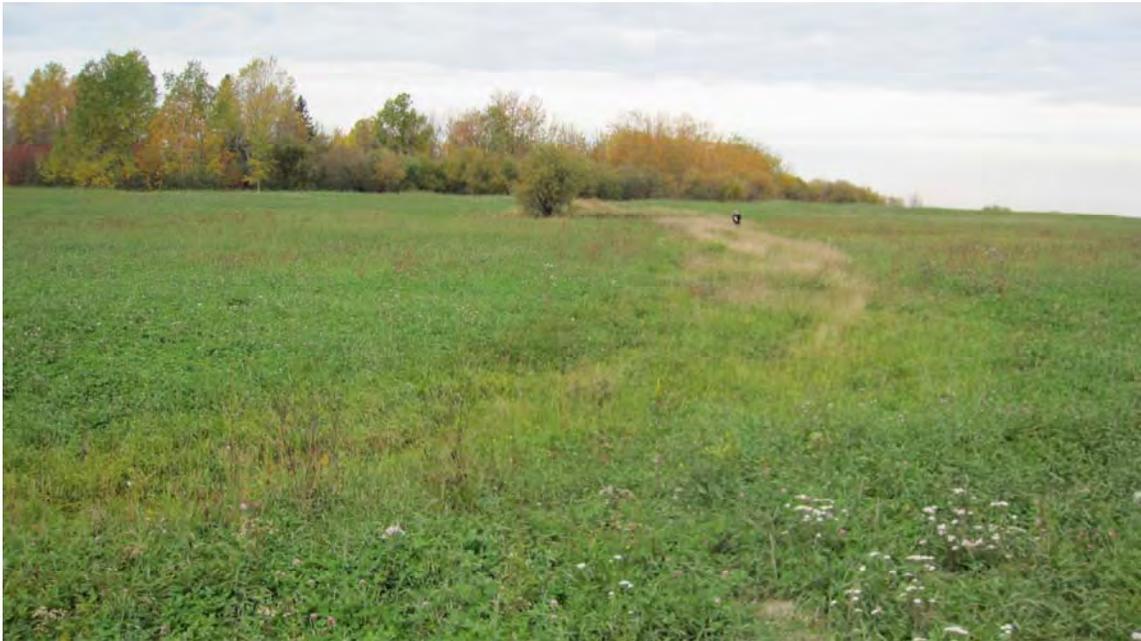
During the site investigations, two grassed swales were identified on the central portion of the Project Location (Figure 1.1). These grassed swales are situated in an east-west manner, respectively, between the woodland on the west side of the Project Location and the woodland/Munroe Creek valley to the east. The swales exist in areas of low topography on the agricultural fields, and likely receive occasional stormwater runoff inputs from the surrounding land. The swales are very shallow (i.e., can be driven/tilled through) and range in width along their length, from several meters to approximately 10 m. No standing water was observed within the grassed swales during the time of the site investigations. The majority of water runoff caught in the swales is likely absorbed by

vegetation, or dries up within. Vegetation within the swales included primarily grasses with some forbs (Figure 4.5).

These grassed swales were not found to be water body features. As per the REA Regulation, temporary channels for surface drainage, such as furrows, or shallow channels that can be tilled or driven through, are not considered intermittent streams or water bodies (Section 1.2)

**Figure 4.5 View of Grassed Swale on Central Portion of Project Location, Facing West**
