Belleville South Solar Project

Draft Water Body Site Investigation Report

H334844-0000-07-124-0041

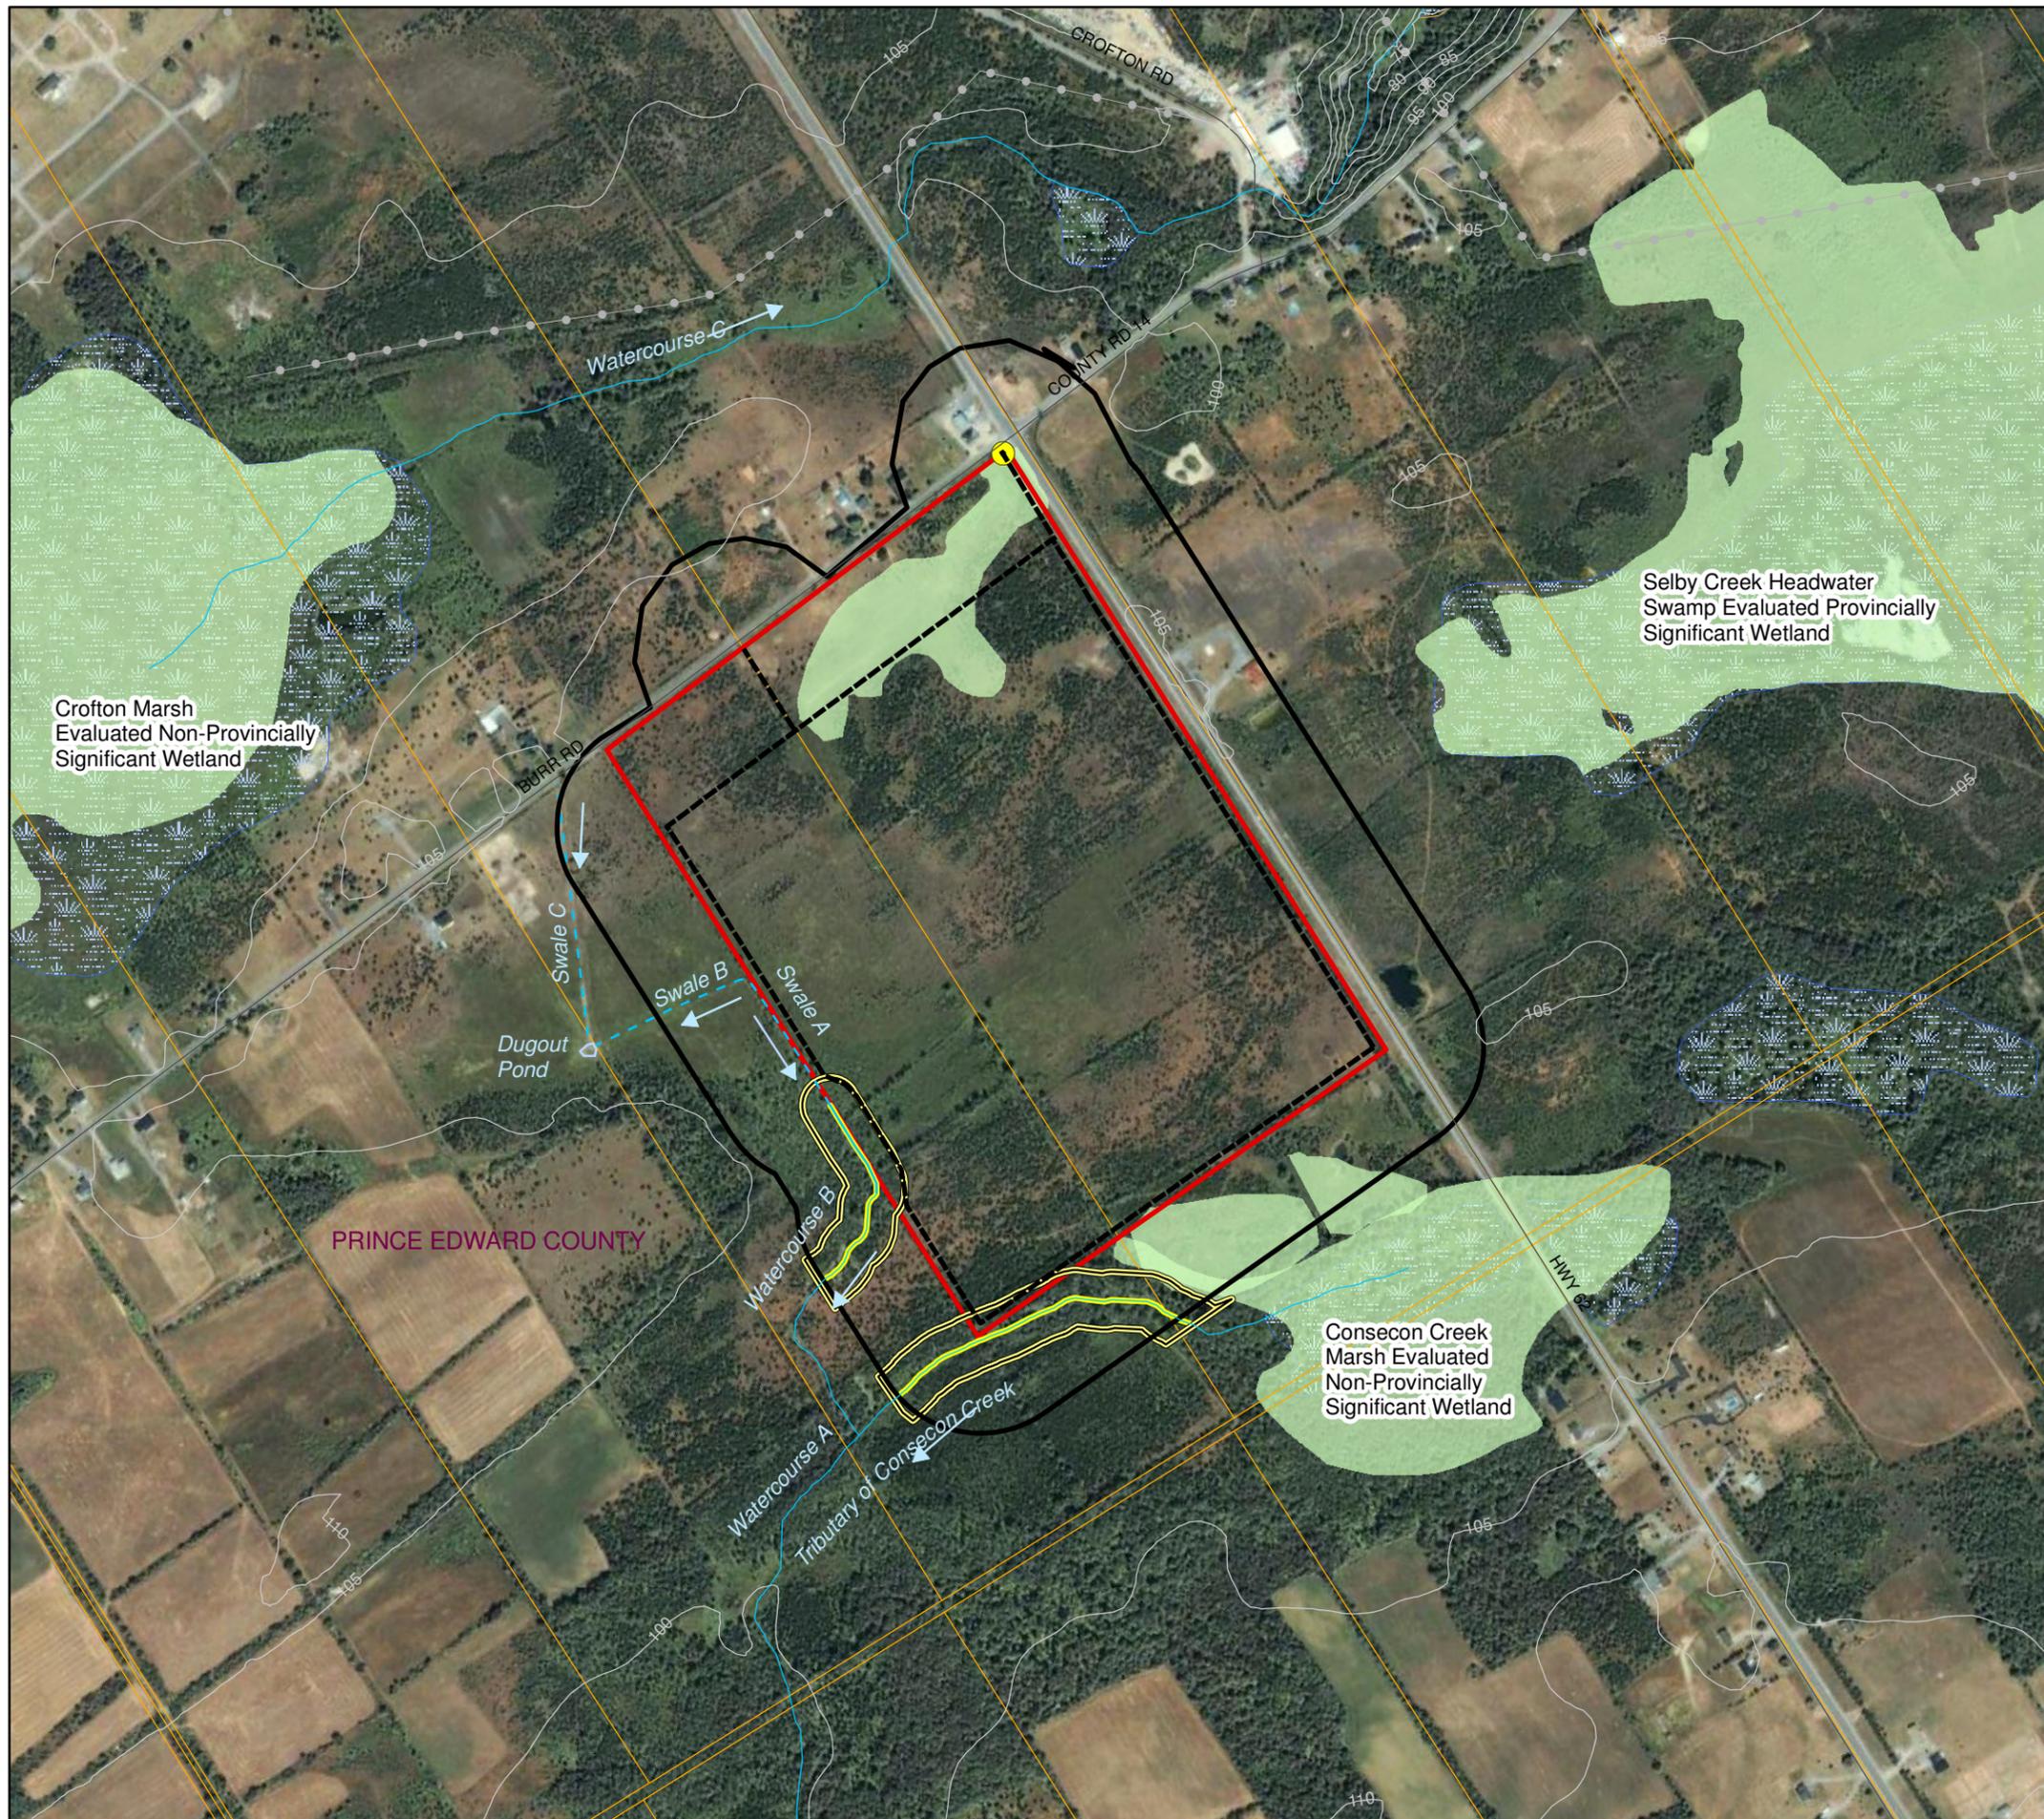
Figure 4.1
 Northland Power Inc.
 Belleville South Solar Project
 Water Body and
 Project Boundaries **HATCH™**

This section documents the results of the Site Investigation and discusses specific water features observed on and adjacent to the subject property. Features noted in the following sections, including the Project footprint boundary and the average annual high water mark and 30-m setback areas associated with watercourses are shown in Figure 4.1.

As shown in Figure 4.1, the Project footprint boundary will be located between 30 and 120 m from the average annual high water mark. Therefore, an EIS will be required to assess potential effects on this watercourse since it meets the setback requirements of the REA Regulation.

Based on the results of the site investigation and the proposed Project components and boundaries shown in Figure 4.1, the Project will be located between 30 and 120 m of the average annual high water mark of any waterbody. Therefore, an Environmental Impact Study (EIS) is required.

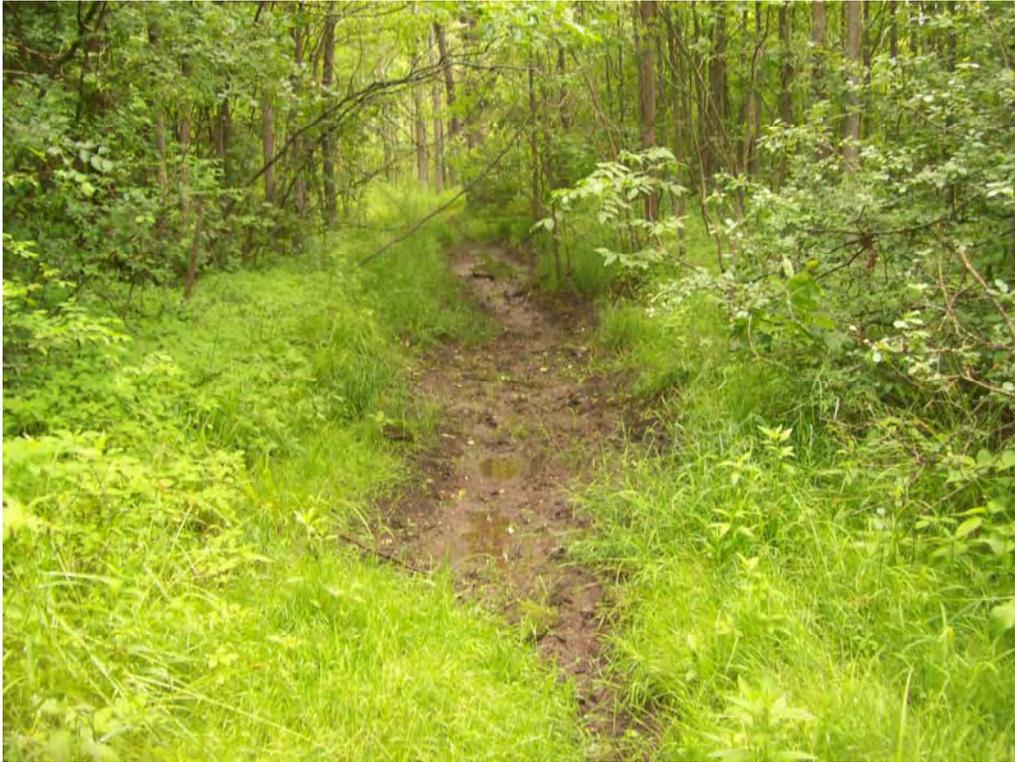
Figure 4.2 Watercourse A South of the Project Site

The channel bed is approximately 1 to 1.5 m wide with primarily mud substrate. Sections of the bed are open with relatively little vegetation (see Figure 4.2), while others are sections have higher amounts of vegetation (primarily grasses and sedges) on the channel bed and banks (Figure 4.3). Riparian vegetation consists of grasses, sedges and ground cover species in a relatively narrow band (approximately 1 to 3 m from the channel edge), bordered by shrubs and trees. Some areas of the woodlot have high density canopy cover while others are more open.

The site investigation has confirmed that Watercourse A is an intermittent stream. There was no flow or standing water in the watercourse during the site investigation, but the channel bed was largely free of vegetation or contained vegetation that requires continuously saturated ground conditions.

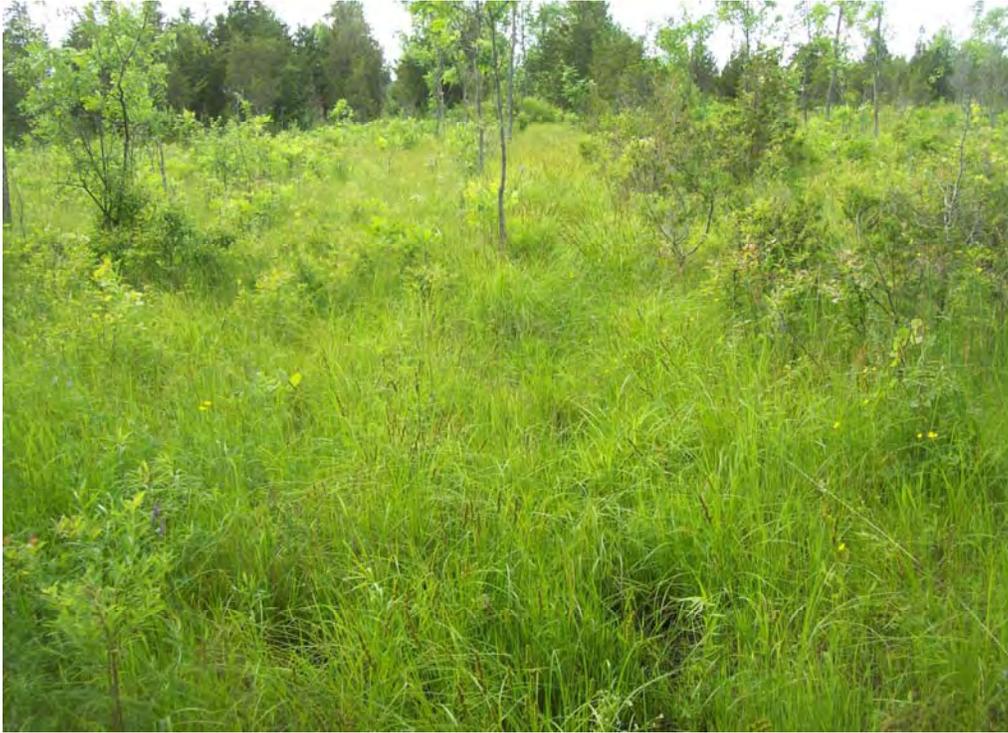
Figure 4.4 Upstream Grassy Swale Reach of Watercourse B

There was no flow or standing water in any reach of Watercourse B during the June site investigation. The upper reach of the channel consists of a poorly defined, grassy swale with a mix of vegetation species, including some upland and less water tolerant species, in addition to a variety of sedges and grasses. Given the presence of such vegetation community, this portion of the watercourse (as shown in Figure 4.1) does not meet the definition of a watercourse as per the REA Regulation. A photograph of this section of Watercourse B is provided in Figure 4.4.

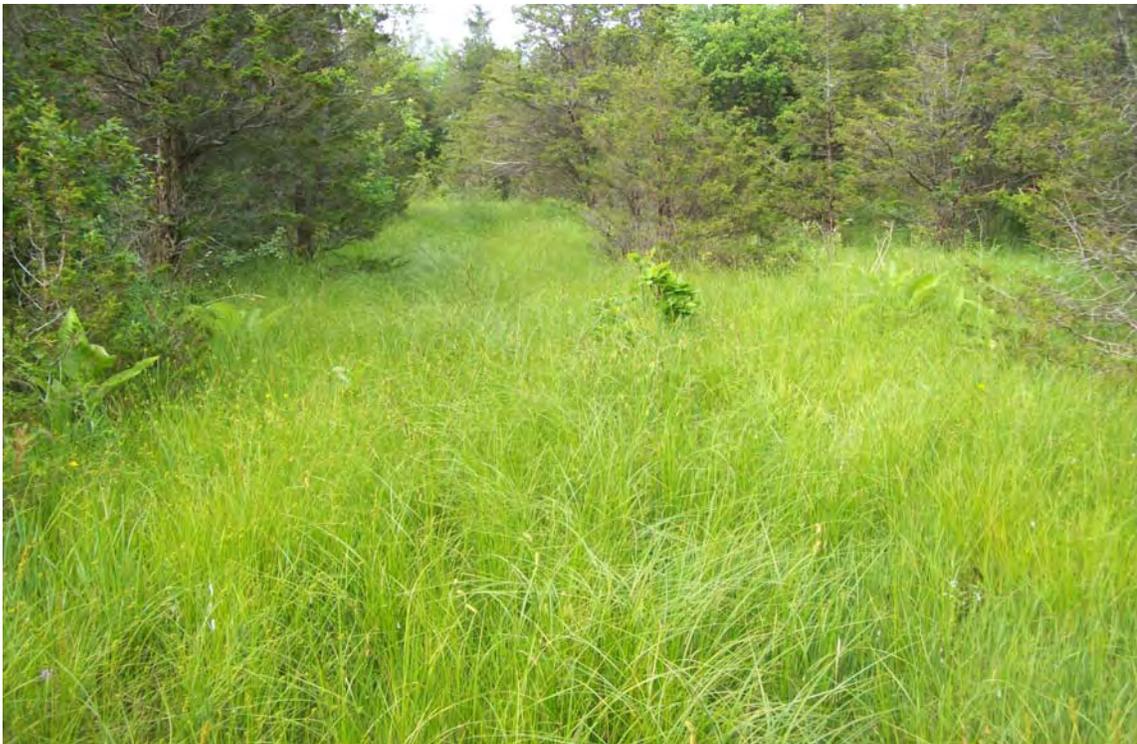
Figure 4.5 Lower Reaches of Watercourse B Adjacent to the Project Site

However, the lower section of the watercourse has vegetation communities that are more indicative of those that do require continuously saturated soils (i.e., predominantly sedges) and therefore it does meet the definition of an intermittent watercourse. The channel remains poorly defined, as it flows through a mix of relatively open shrub meadows and denser wooded areas. Substrate is predominantly mud and fine mineral soils.

This section of the channel appears to serve primarily as stormwater conveyance, but may provide some intermittent aquatic habitat for tolerant fish and invertebrates. A photograph is provided in Figure 4.5.

The site investigation has confirmed that the lower portion of Watercourse B is an intermittent stream. The average annual high water mark, based on top of bank features and riparian vegetation communities is shown in Figure 4.1.
