Long Lake Solar Project Water Body Site Investigation Report

Water Body
Site Investigation Report

H334844-0000-07-124-0299

October 18, 2012

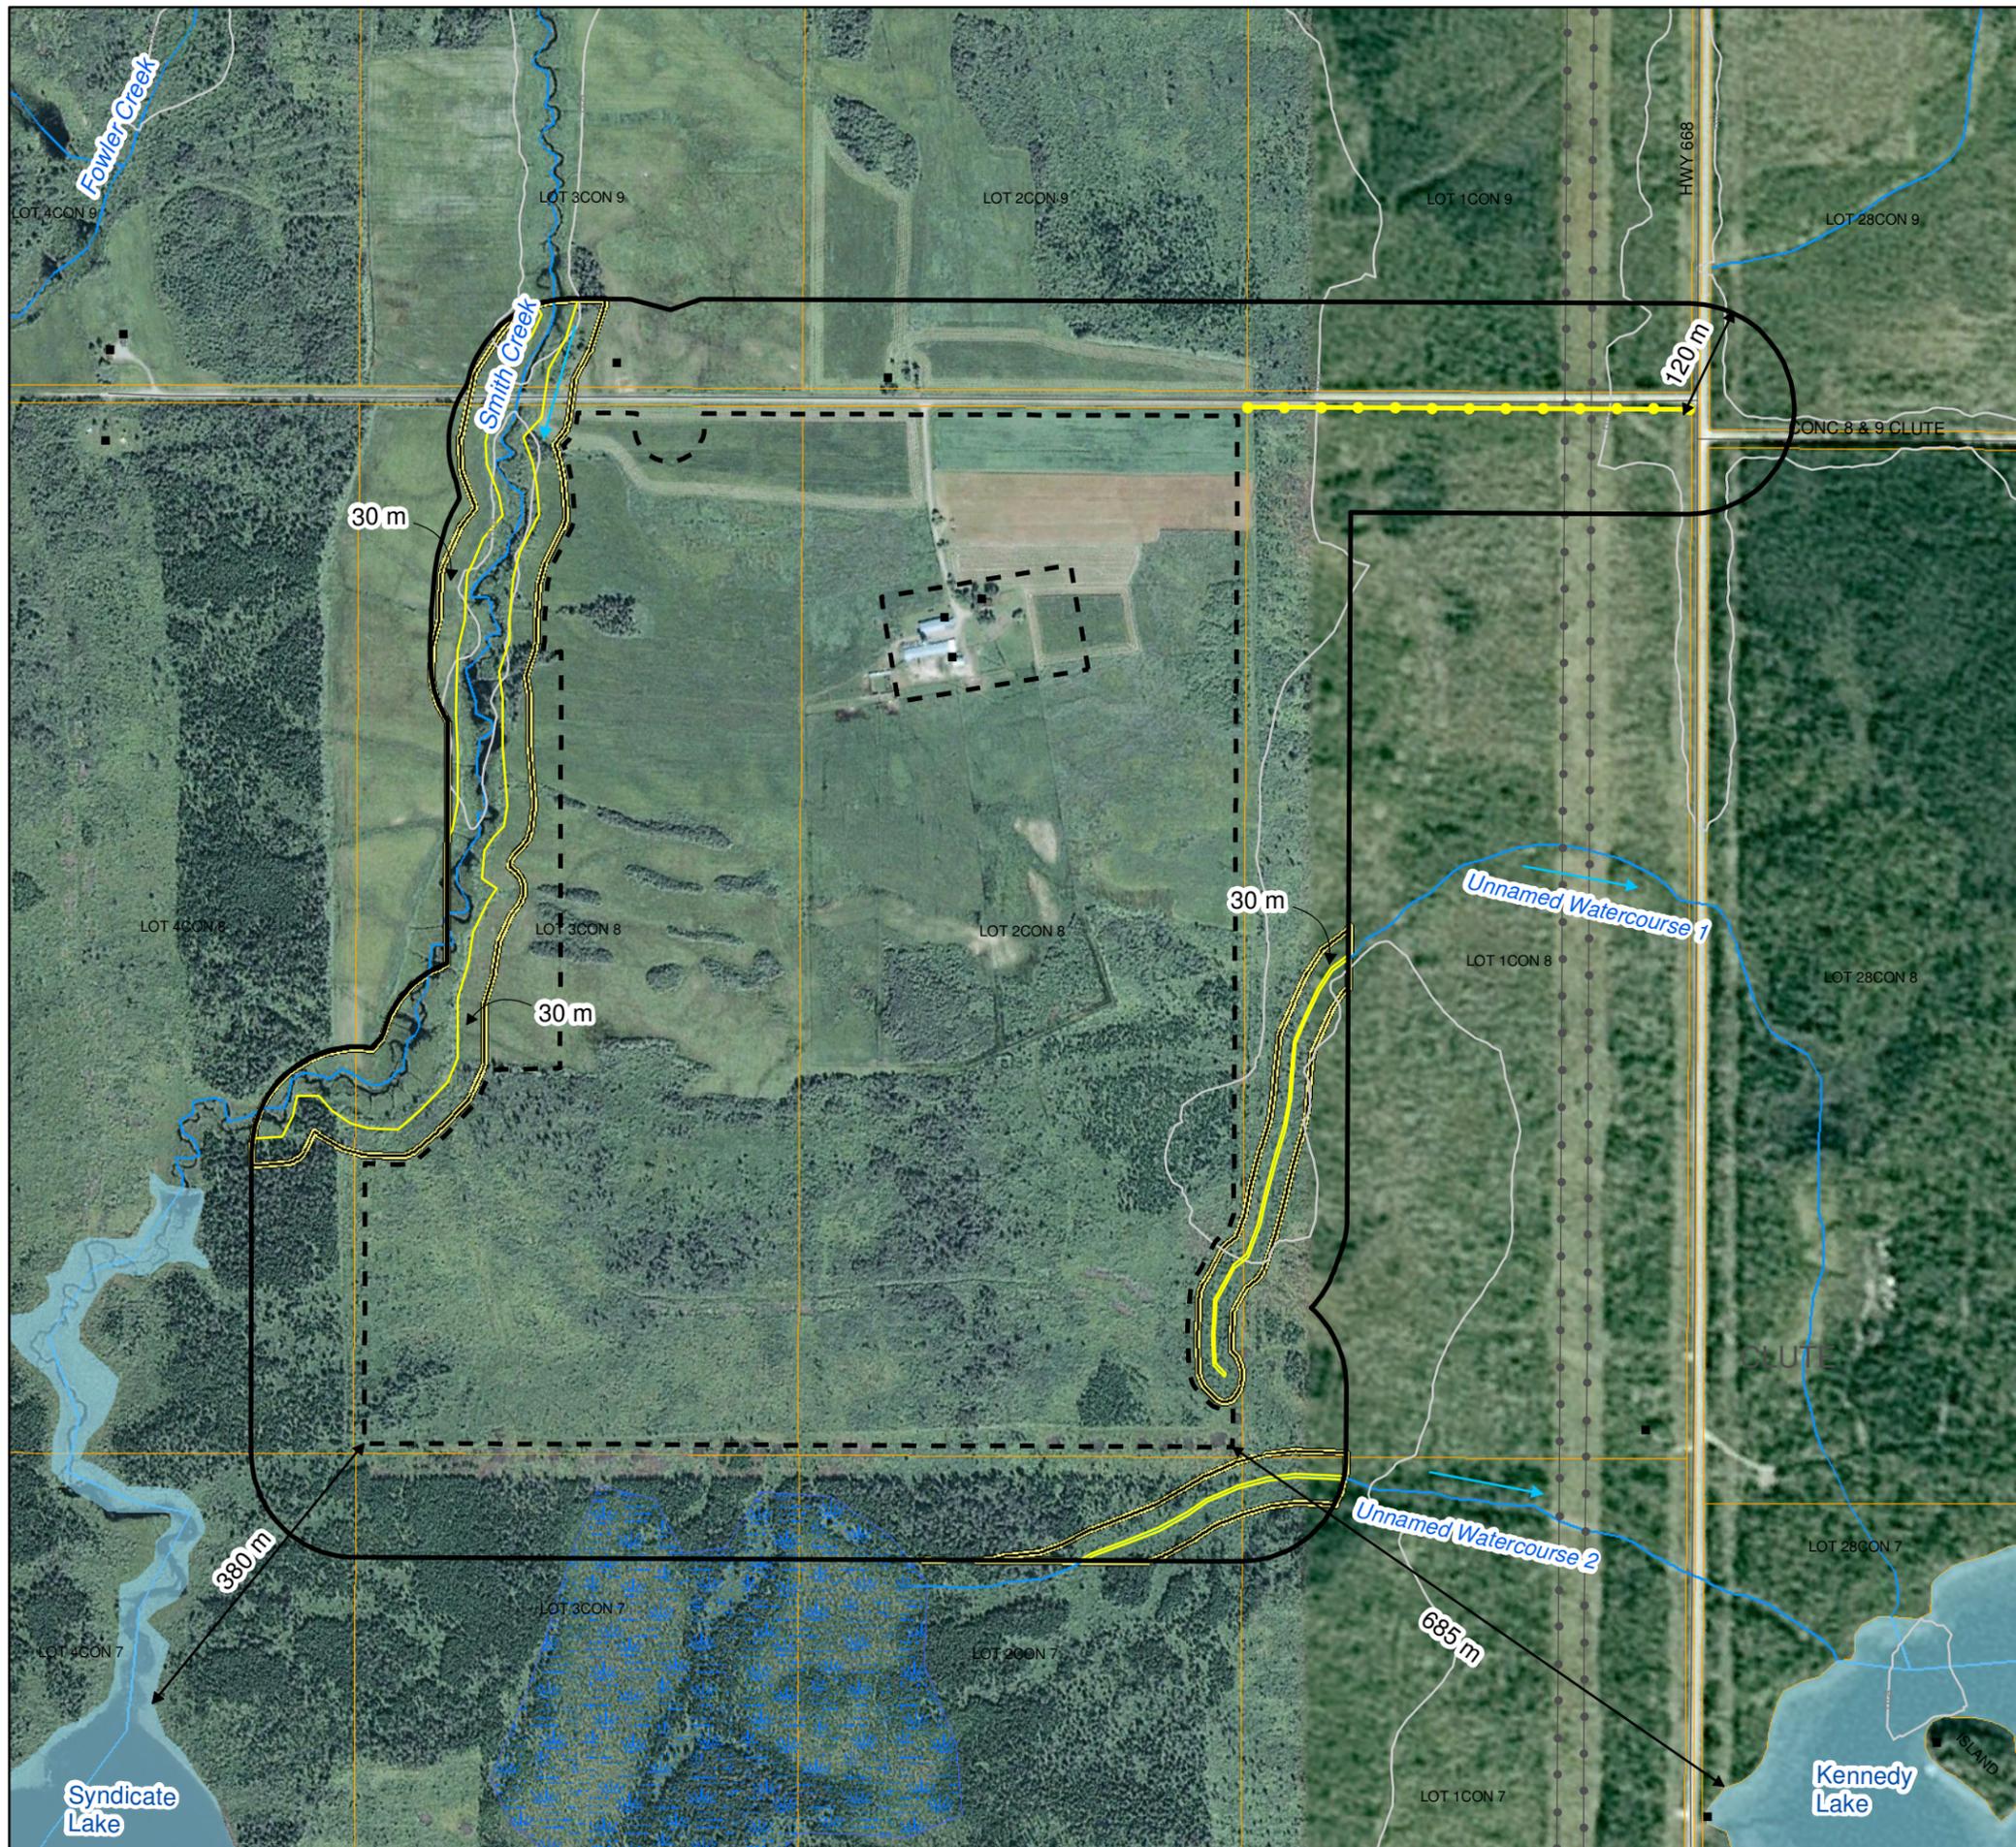
Figure 1.1
 Northland Power Inc.
Long Lake Solar Project
Water Body
Site Investigation Results

As shown in Figure 1.1 and summarized in Table 5.1, the Project Location is located within 120 m of the average annual high water mark of three watercourses (Smith Creek, Unnamed Watercourse 1 and Unnamed Watercourse 2). As a result, a Water Body Environmental Impact Study will be prepared to address potential negative environmental effects to the identified water body features associated with the proposed development. Recommendations on mitigation measures will be provided to ensure the long term ecological health and integrity of these water body features.

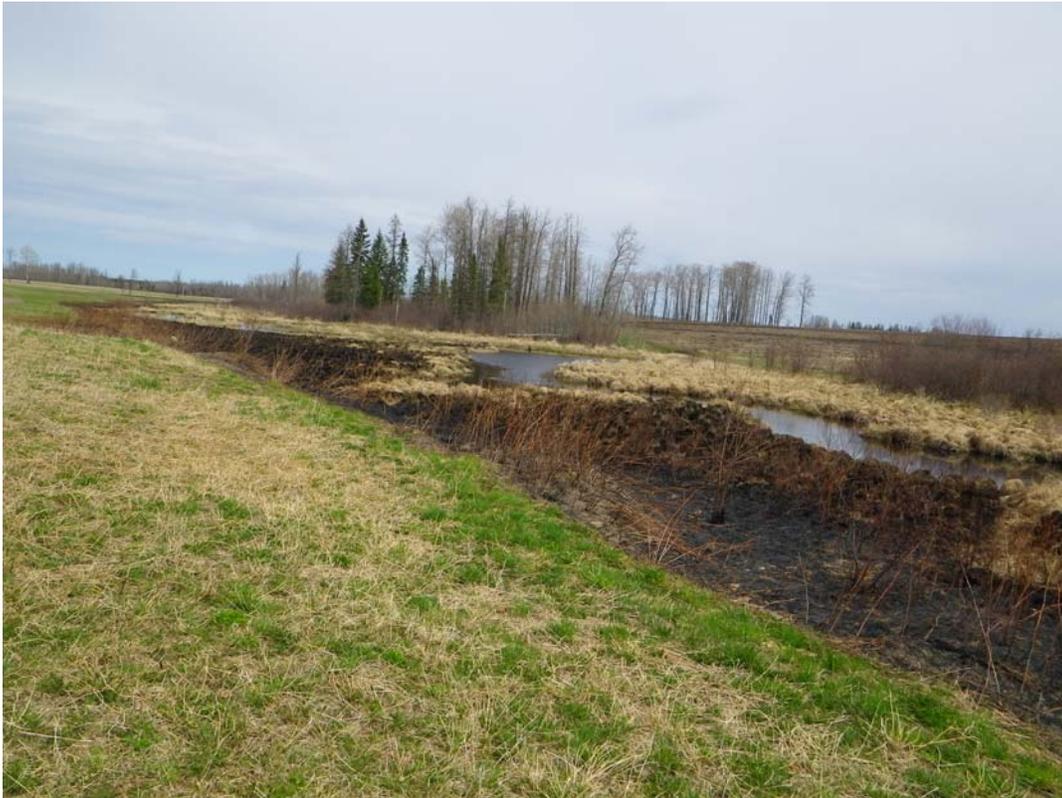
Figure 4.1 View of Smith Creek Adjacent to Project Location

The Water Body Records Review Report (Hatch Ltd., 2012) identified a portion of Smith Creek on the western portion of the property on which the project is located. A site investigation, completed on May 18, 2011 (i.e. Site Investigation 2), confirmed the presence of this water body feature. The site investigator assessed the portion of creek which resided on the project property. The creek contains several existing and previous beaver dams and lodges within the property, which significantly alters the water’s surface area. Agricultural fields exist on all sides of the creek on the project property, with tilled land extending down to a meadow marsh type wetland which borders both shores. It is evident that meadow marsh area periodically floods through beaver activity or freshet flows, therefore the border between tilled land and the meadow marsh habitat was considered the average annual high water mark of Smith Creek. Small forage fish were observed within the creek’s channels and ponds.

A photograph of Smith Creek approximately half way through the property in northern orientation is provided in Figure 4.1.

Smith Creek is a permanent stream that provides continual flows in an average year and, therefore, meets the definition of a water body, according to the REA Regulation. The Project will encroach to within 30 m of the average annual high water mark of an approximately 250-m long portion of Smith Creek in the northwest corner of the property. Given that Smith Creek is located within 120 m of the Project Location, a Water Body Environmental Impact Study Report is required to address the potential environmental effects on this water body feature as a result of the Project.

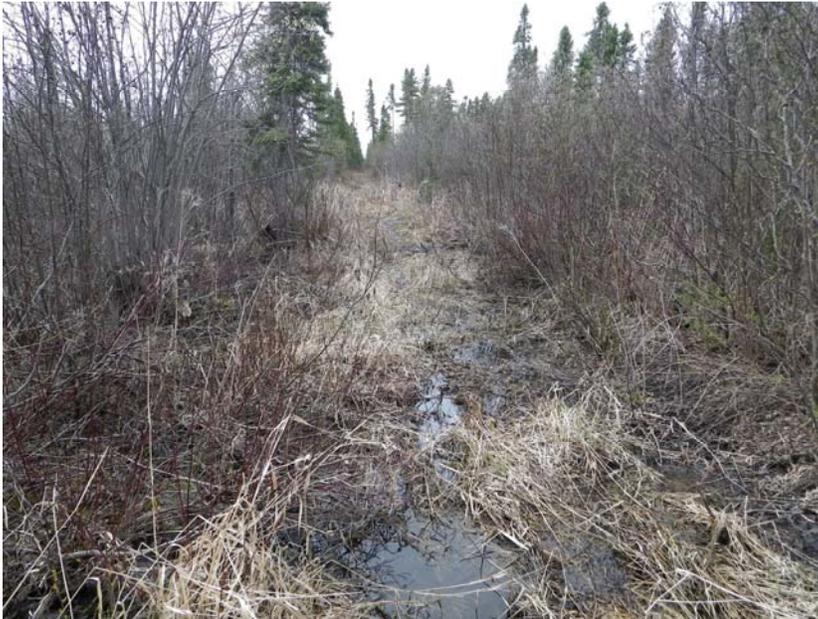
Figure 4.2 View of Unnamed Watercourse 1 within Alder Wetland

The site investigation completed on May 18th, 2011 (i.e. site investigation 2) confirmed the presence of this unnamed tributary of Kennedy Lake (noted as Unnamed Watercourse 1 on Figure 1.1), which was previously identified in the Water Body Records Review Report (Hatch Ltd., 2012). An assessment of this water body feature determined that Unnamed Watercourse 1 meets the definition of a water body according to the REA Regulation.

Unnamed Watercourse 1 originates in the southeastern corner of the property and flows north easterly off the property at which time it makes a relatively abrupt 180° turn to flow south towards Kennedy Lake. The channel is segmented on the property as it meanders through the wetland head waters. The owner of the property on which the Project is located indicated the area in which the tributary originates remains wet throughout the year and thus it is anticipated that the watercourse is permanent. Further downstream towards Kennedy Lake, off the project property, the watercourse gains more distinct watercourse features. A photograph of the tributary is provided in Figure 4.2.

Unnamed Watercourse 1 meets the definition of a permanent stream according to the REA Regulation. As the Project Location is within 120 m of the average annual high water mark of this permanent stream, a Water Body Environmental Impact Study will be completed to assess the potential environmental impacts associated with the Project.
