**STAGE 2 ARCHAEOLOGICAL ASSESSMENT
McLEAN'S MOUNTAIN WIND FARM
Part Lots 12-15, Concession 3
Geographic Township of Howland
Part Lot 24, Concession 12
Geographic Township of Bidwell and
Goat Island (formerly known as Mink Island area)
Northeastern Manitoulin Island (NEMI)
District of Manitoulin**

**Original Report
F-000522-WIN-130-601, F-000520-WIN-130-601**

Prepared for
Northland Power
and
Ministry of Tourism and Culture

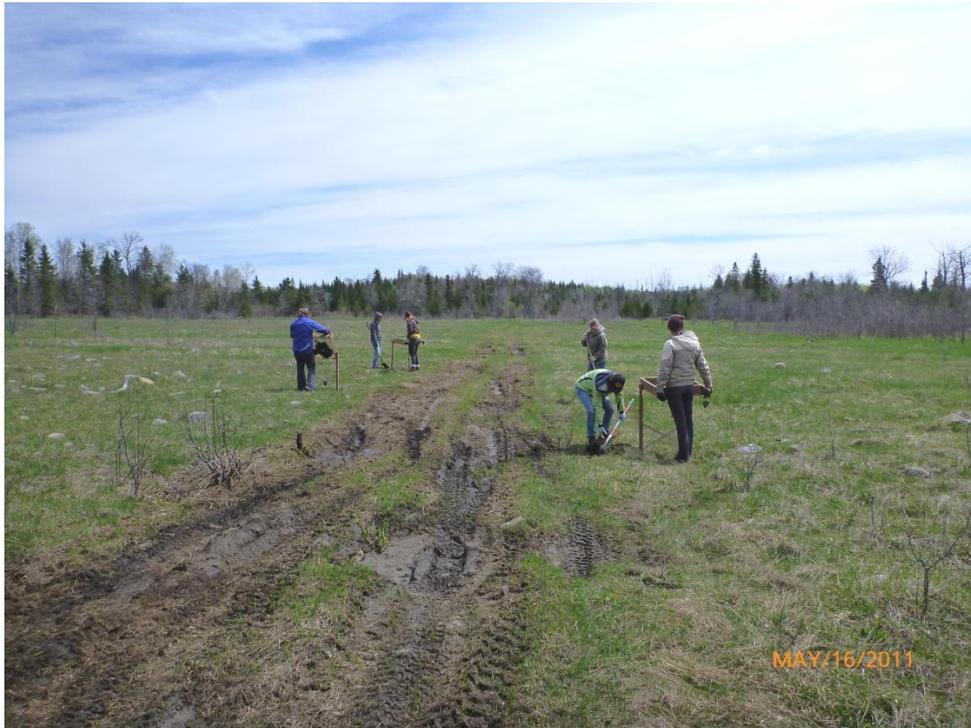
Photograph 1
Facing East along Access Road

The study area was generally level, and was intersected by two small freshets cutting across the access road to Perch Lake. The area was pasture with high rock content. Test pits were approximately 15 cms in depth, and the subsoil was either clay or bedrock. At the eastern end of the study area, a gate and fencing delineated a change in topography, from level (west) to a gradual rise in elevation (east). On the east side of the gate was a small culvert for diverting a small stream to Perch Lake. The disturbance in this area was minimal, and still subject to test pitting. The access road along the elevated area of the property also served as an existing snowmobile and recreational trail. The remnants of a snake rail fence were located along the south side of the trail.

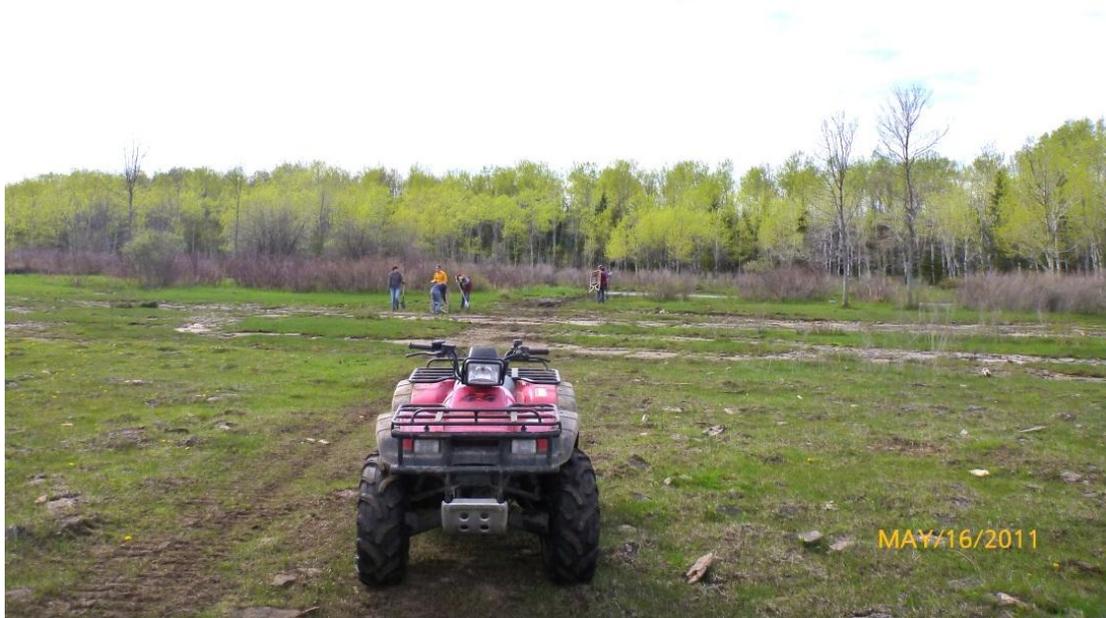
Photograph 5
Facing West towards Perch Creek

The study area was generally level to very gently sloping. There were areas of wet meadow adjacent to the access roads. The area was pasture with high rock content.

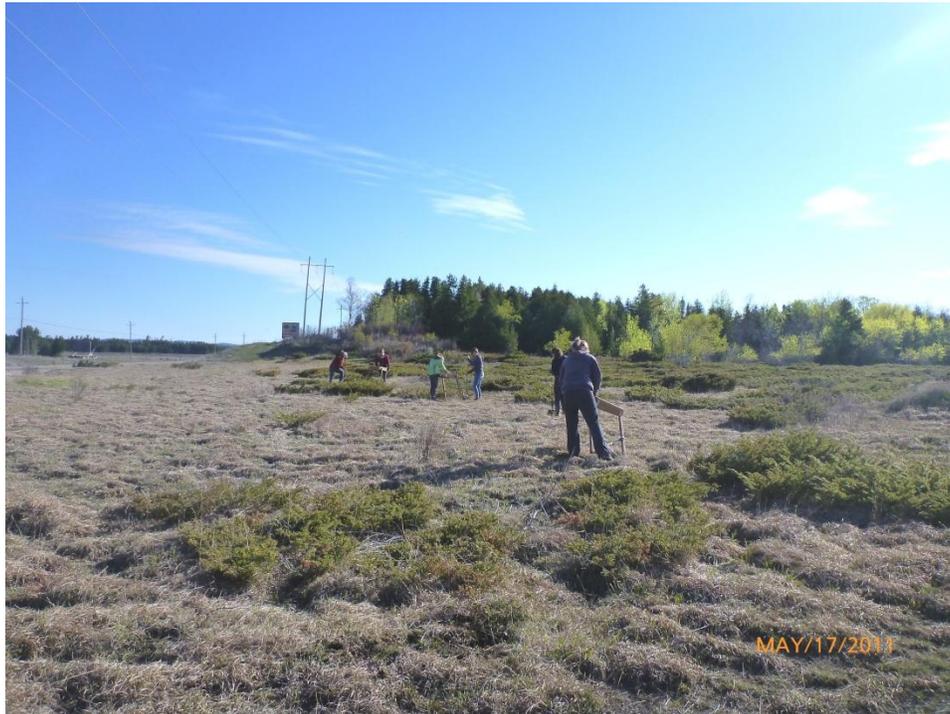
Photograph 7
Test Pitting Easement facing North

There were areas of scrub that were subject to test pitting, and large areas of exposed bedrock and the shoreline. The latter two areas were subject to pedestrian transect survey. Photographs 7-9 illustrate the conditions of the archaeological assessment.

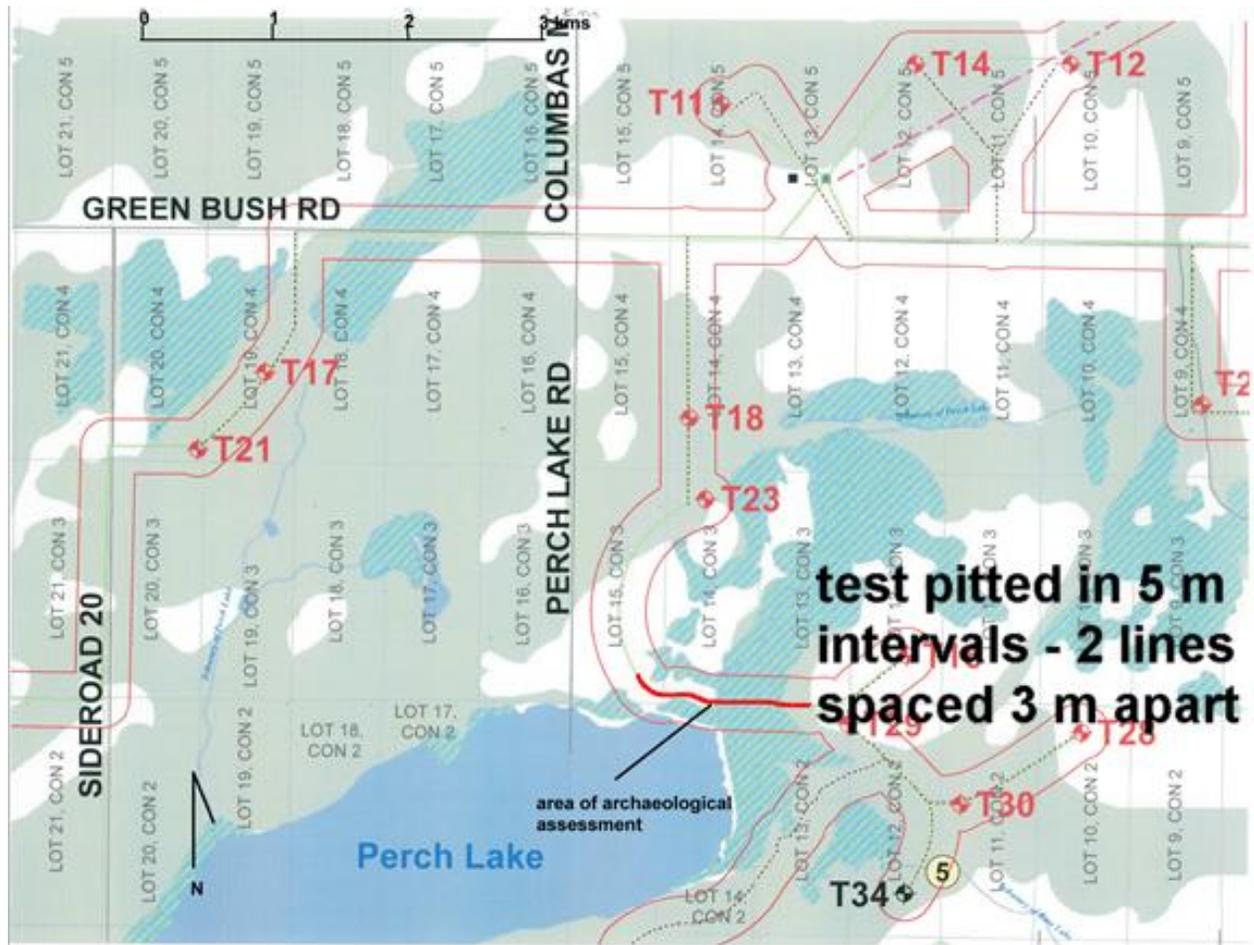
Figure 9
Assessment Methodology Access Road North of Perch Lake

The Perch Lake access road was accessed using ATV's. Areas within 50 m of Perch Lake or any wetlands or other water bodies were assessed using a test pitting methodology. The length of the access road subject to archaeological assessment was approximately 1.5 kms long. No cultural materials were located during the test pitting survey.

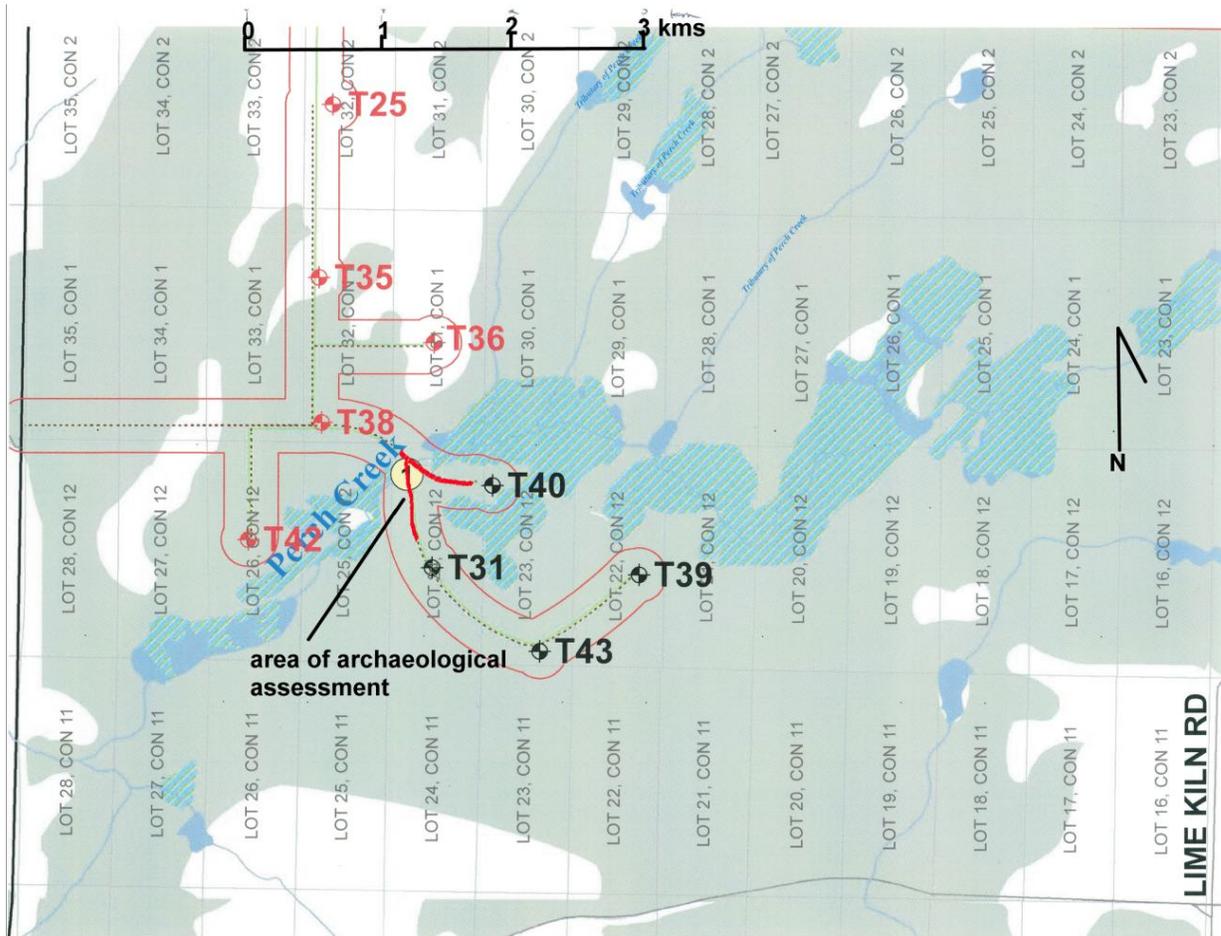
Figure 10
Assessment Methodology Access Roads East of Perch Creek

The Perch Creek access roads were accessed using ATV's. Areas within 50 m of Perch Creek or any wetlands or other water bodies were assessed using a test pitting methodology. The length of the access roads subject to archaeological assessment was approximately 1.25 km long. No cultural materials were located during the test pitting survey.

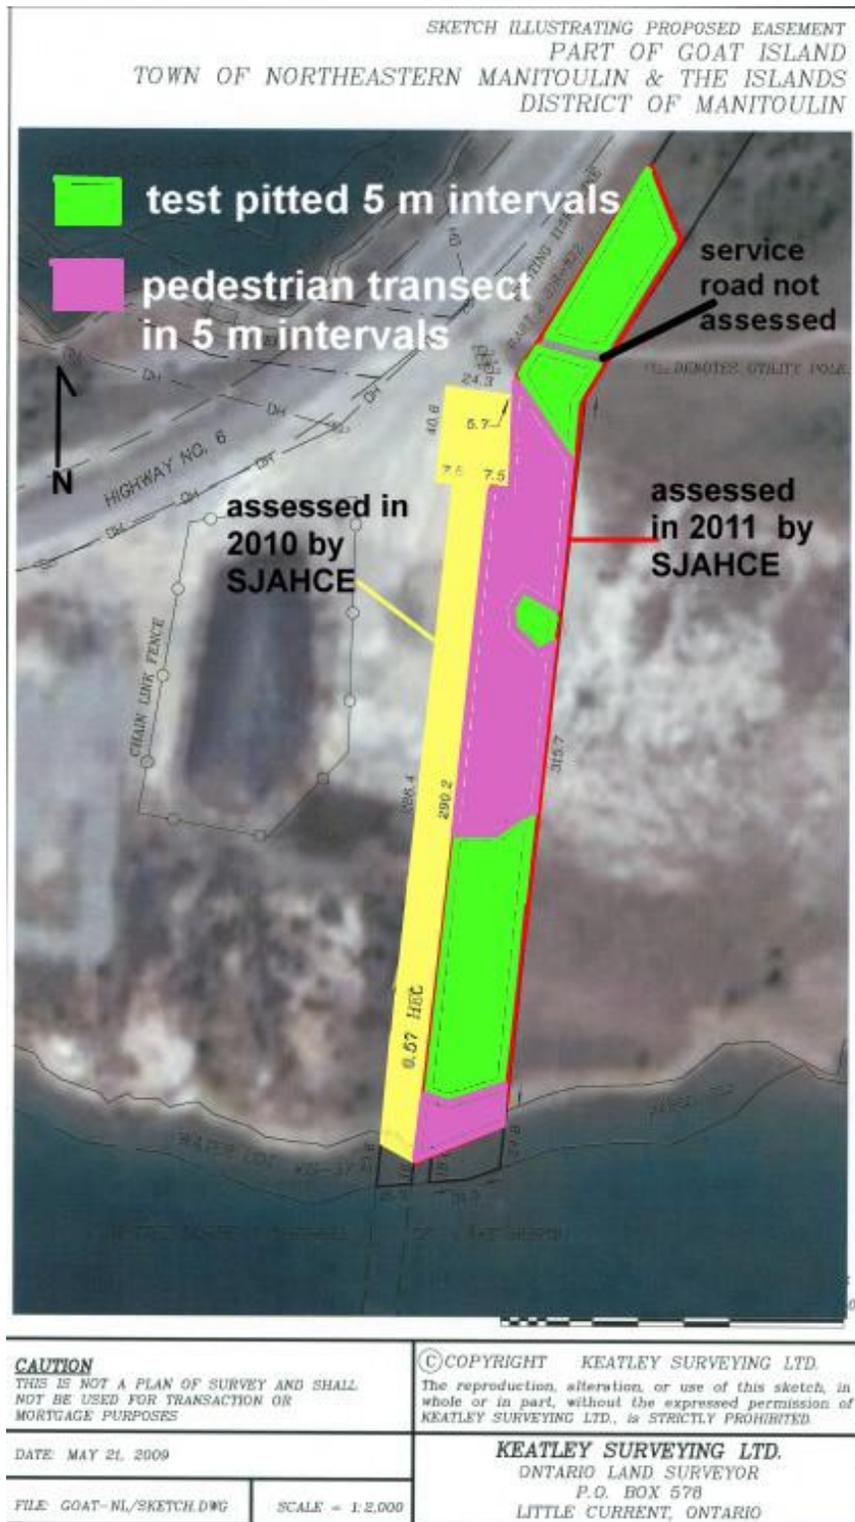
Figure 11
Assessment Methodology Proposed Easement on Goat Island

The Goat Island easement was accessed by crossing the bridge from Little Current over the North Channel and continuing along Highway 6 to a service road located on the east side of Highway 6. A service road intersected the easement area, and was considered to be disturbed to a high degree (road bed) and was therefore not archaeologically assessed.
