**NORTHLAND
POWER**

Abitibi Solar Project

Draft Water Body Site Investigations Report

H334844-0000-07-124-0247

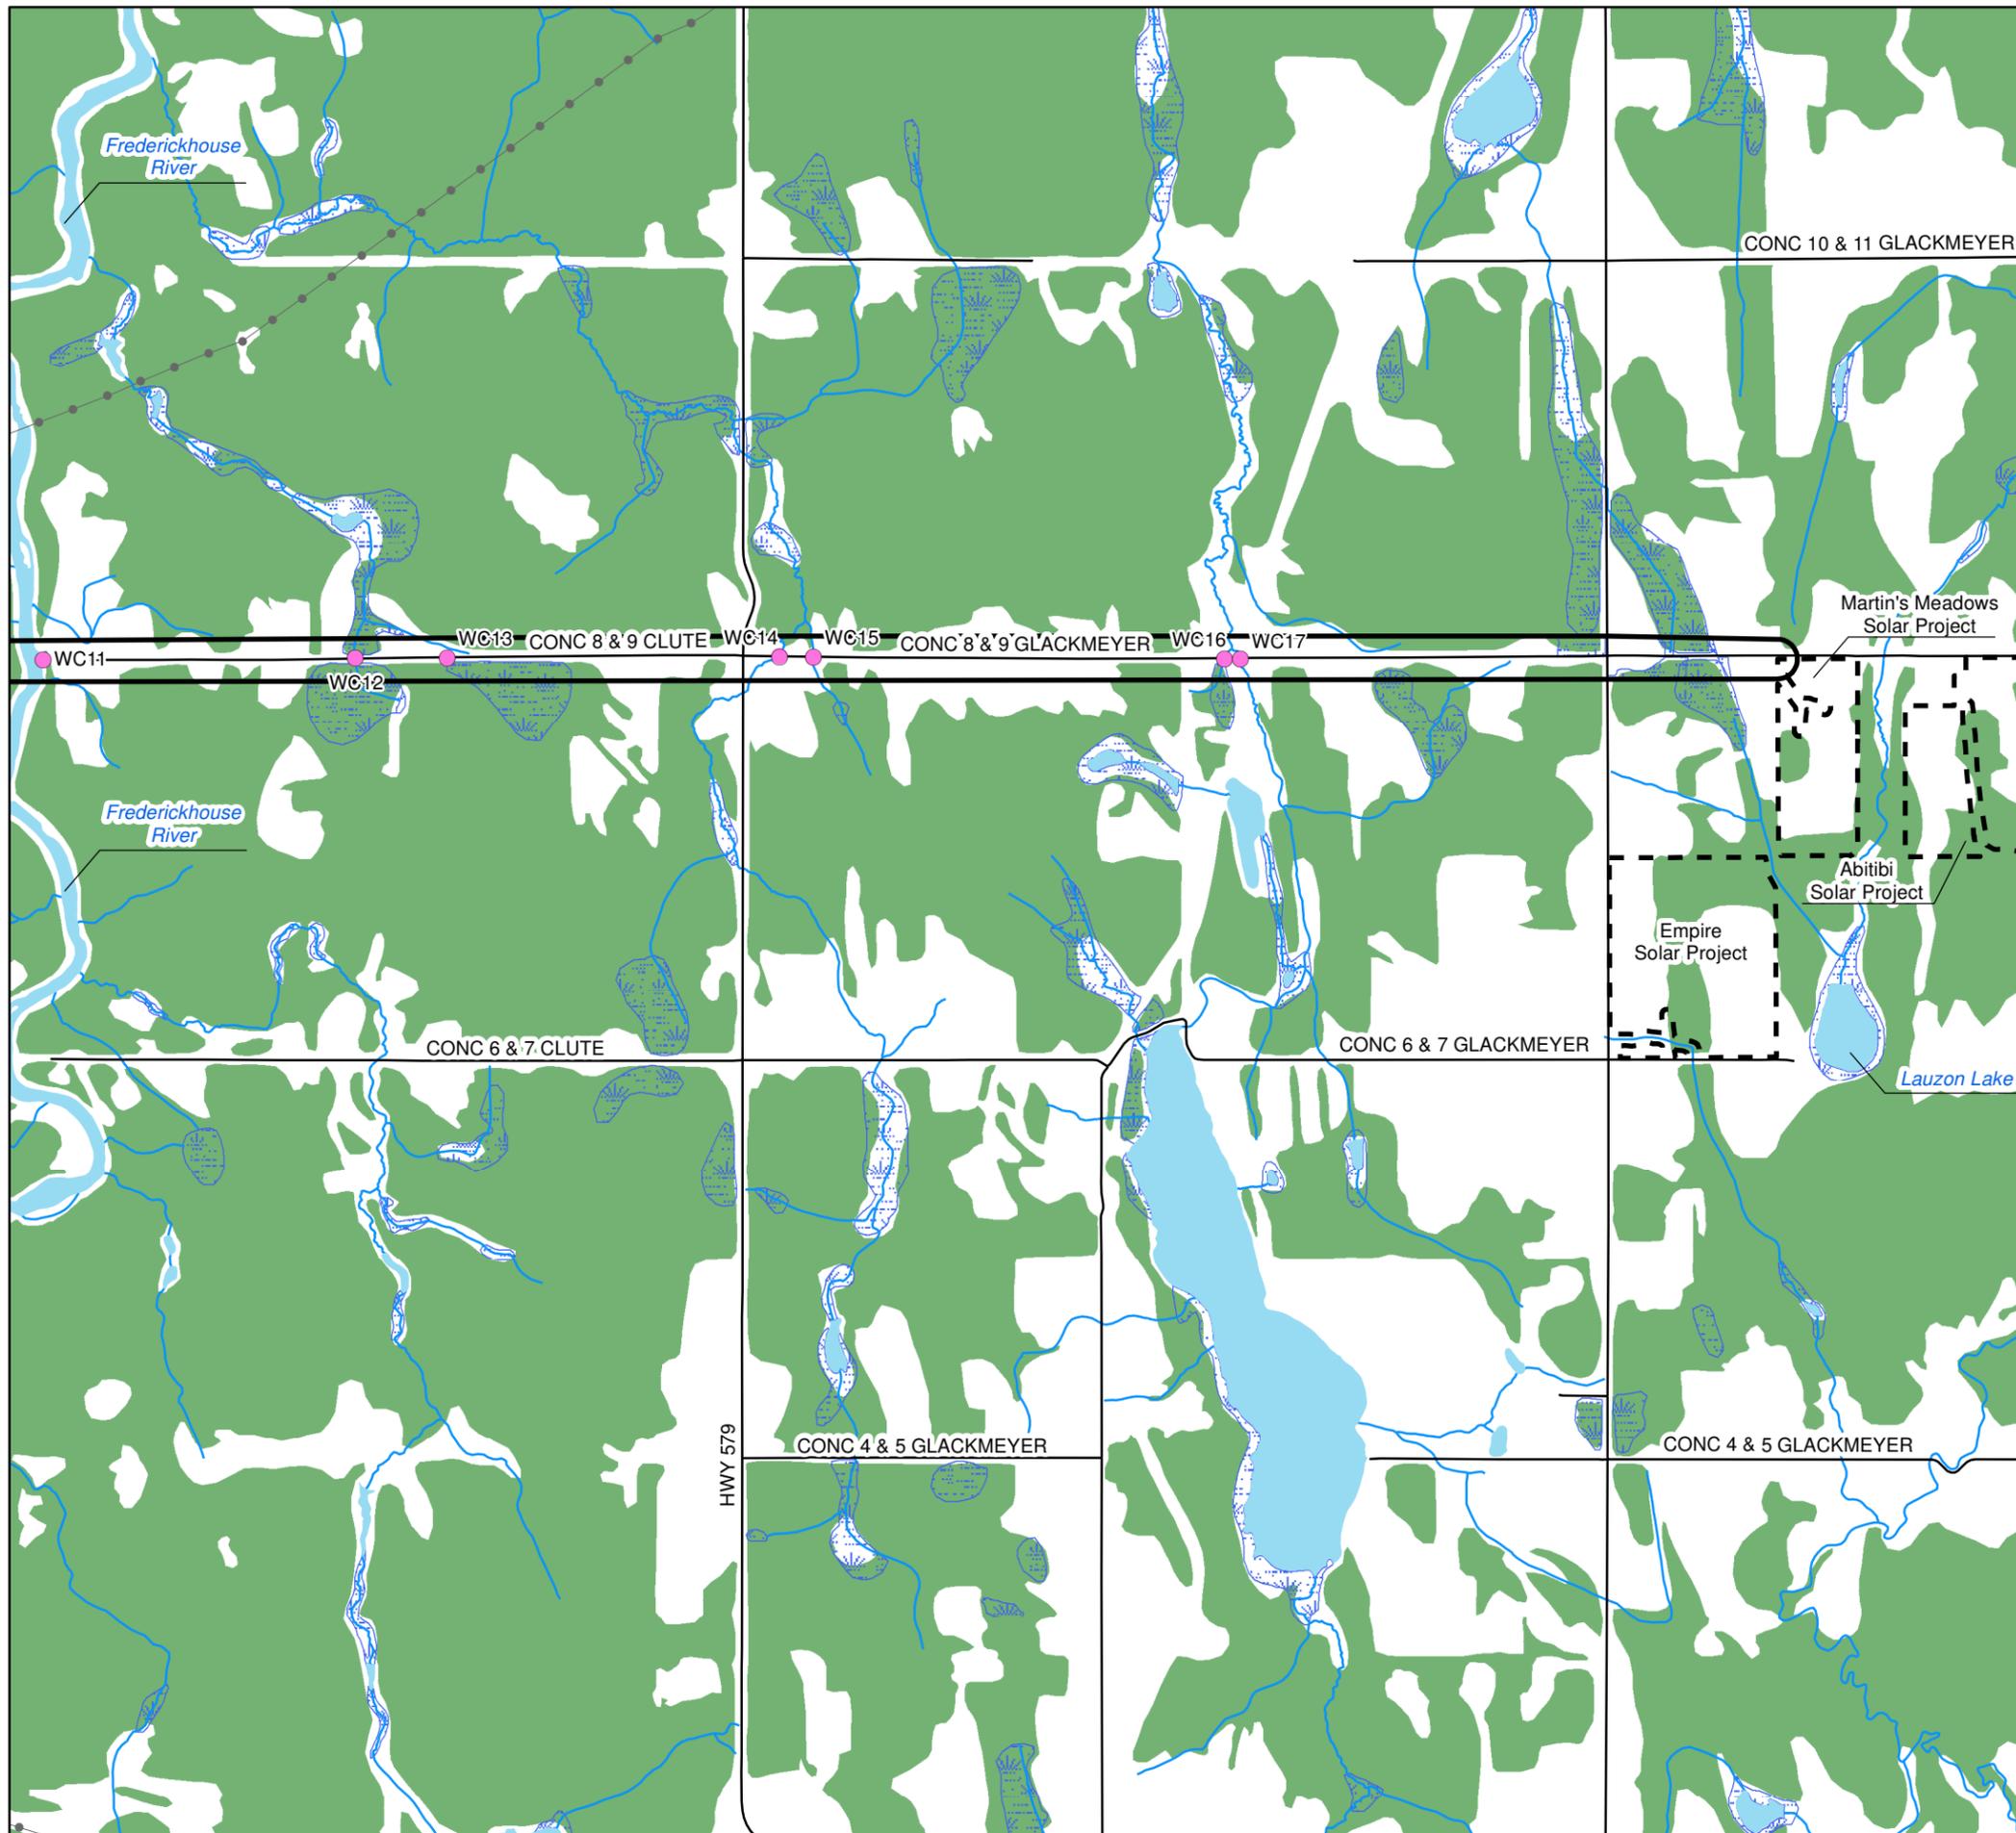
Figure 1.2
 Northland Power Inc.
**Distribution Line Project Location
 (Eastern Half) - Waterbody
 Site Investigation Results**

A total of 38 waterbodies were observed along the distribution line route options, as shown in Figures 1.2 and 1.3, and summarized in Table 4.1, which presents the watercourse identifier (as labelled on Figures 1.2 and 1.3), summary of watercourse observations (watercourse type, average width and depth, substrate, bank vegetation and other observations). There were 36 unnamed watercourses, the Frederickhouse River and Deception Creek. In addition, the proposed distribution line will pass within 120 m of Lower Deception Lake.

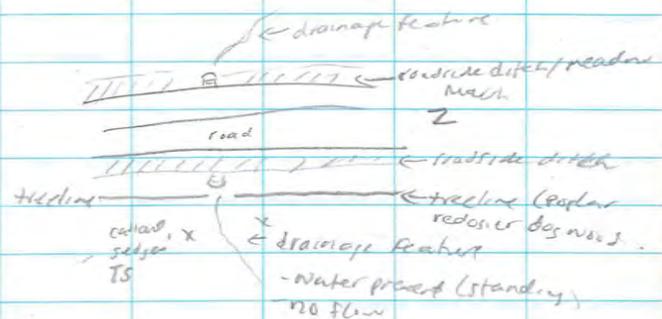
Drainage Feature / Wetland
culvert under road - east & west

- west side - ~~no~~ defined bank, low-lying area / meadow-march - grasses, sedges, cattail

- East side

- drainage swale east into "meadow-march"

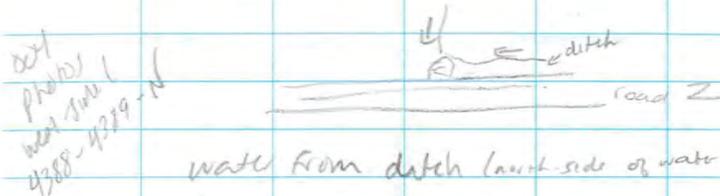
(4) Water Feature (Fower Creek?)

water from ditch (west side of water feature)
flows south into water feature; water
feature flows east

- water present - ~4" deep?
- channel width 1.5-2m
- shrubs, sedges & grasses along bank
organic substrate
