Abitibi Solar Project

Water Body Site Investigations Report

H334844-0000-07-124-0247

October 18, 2012

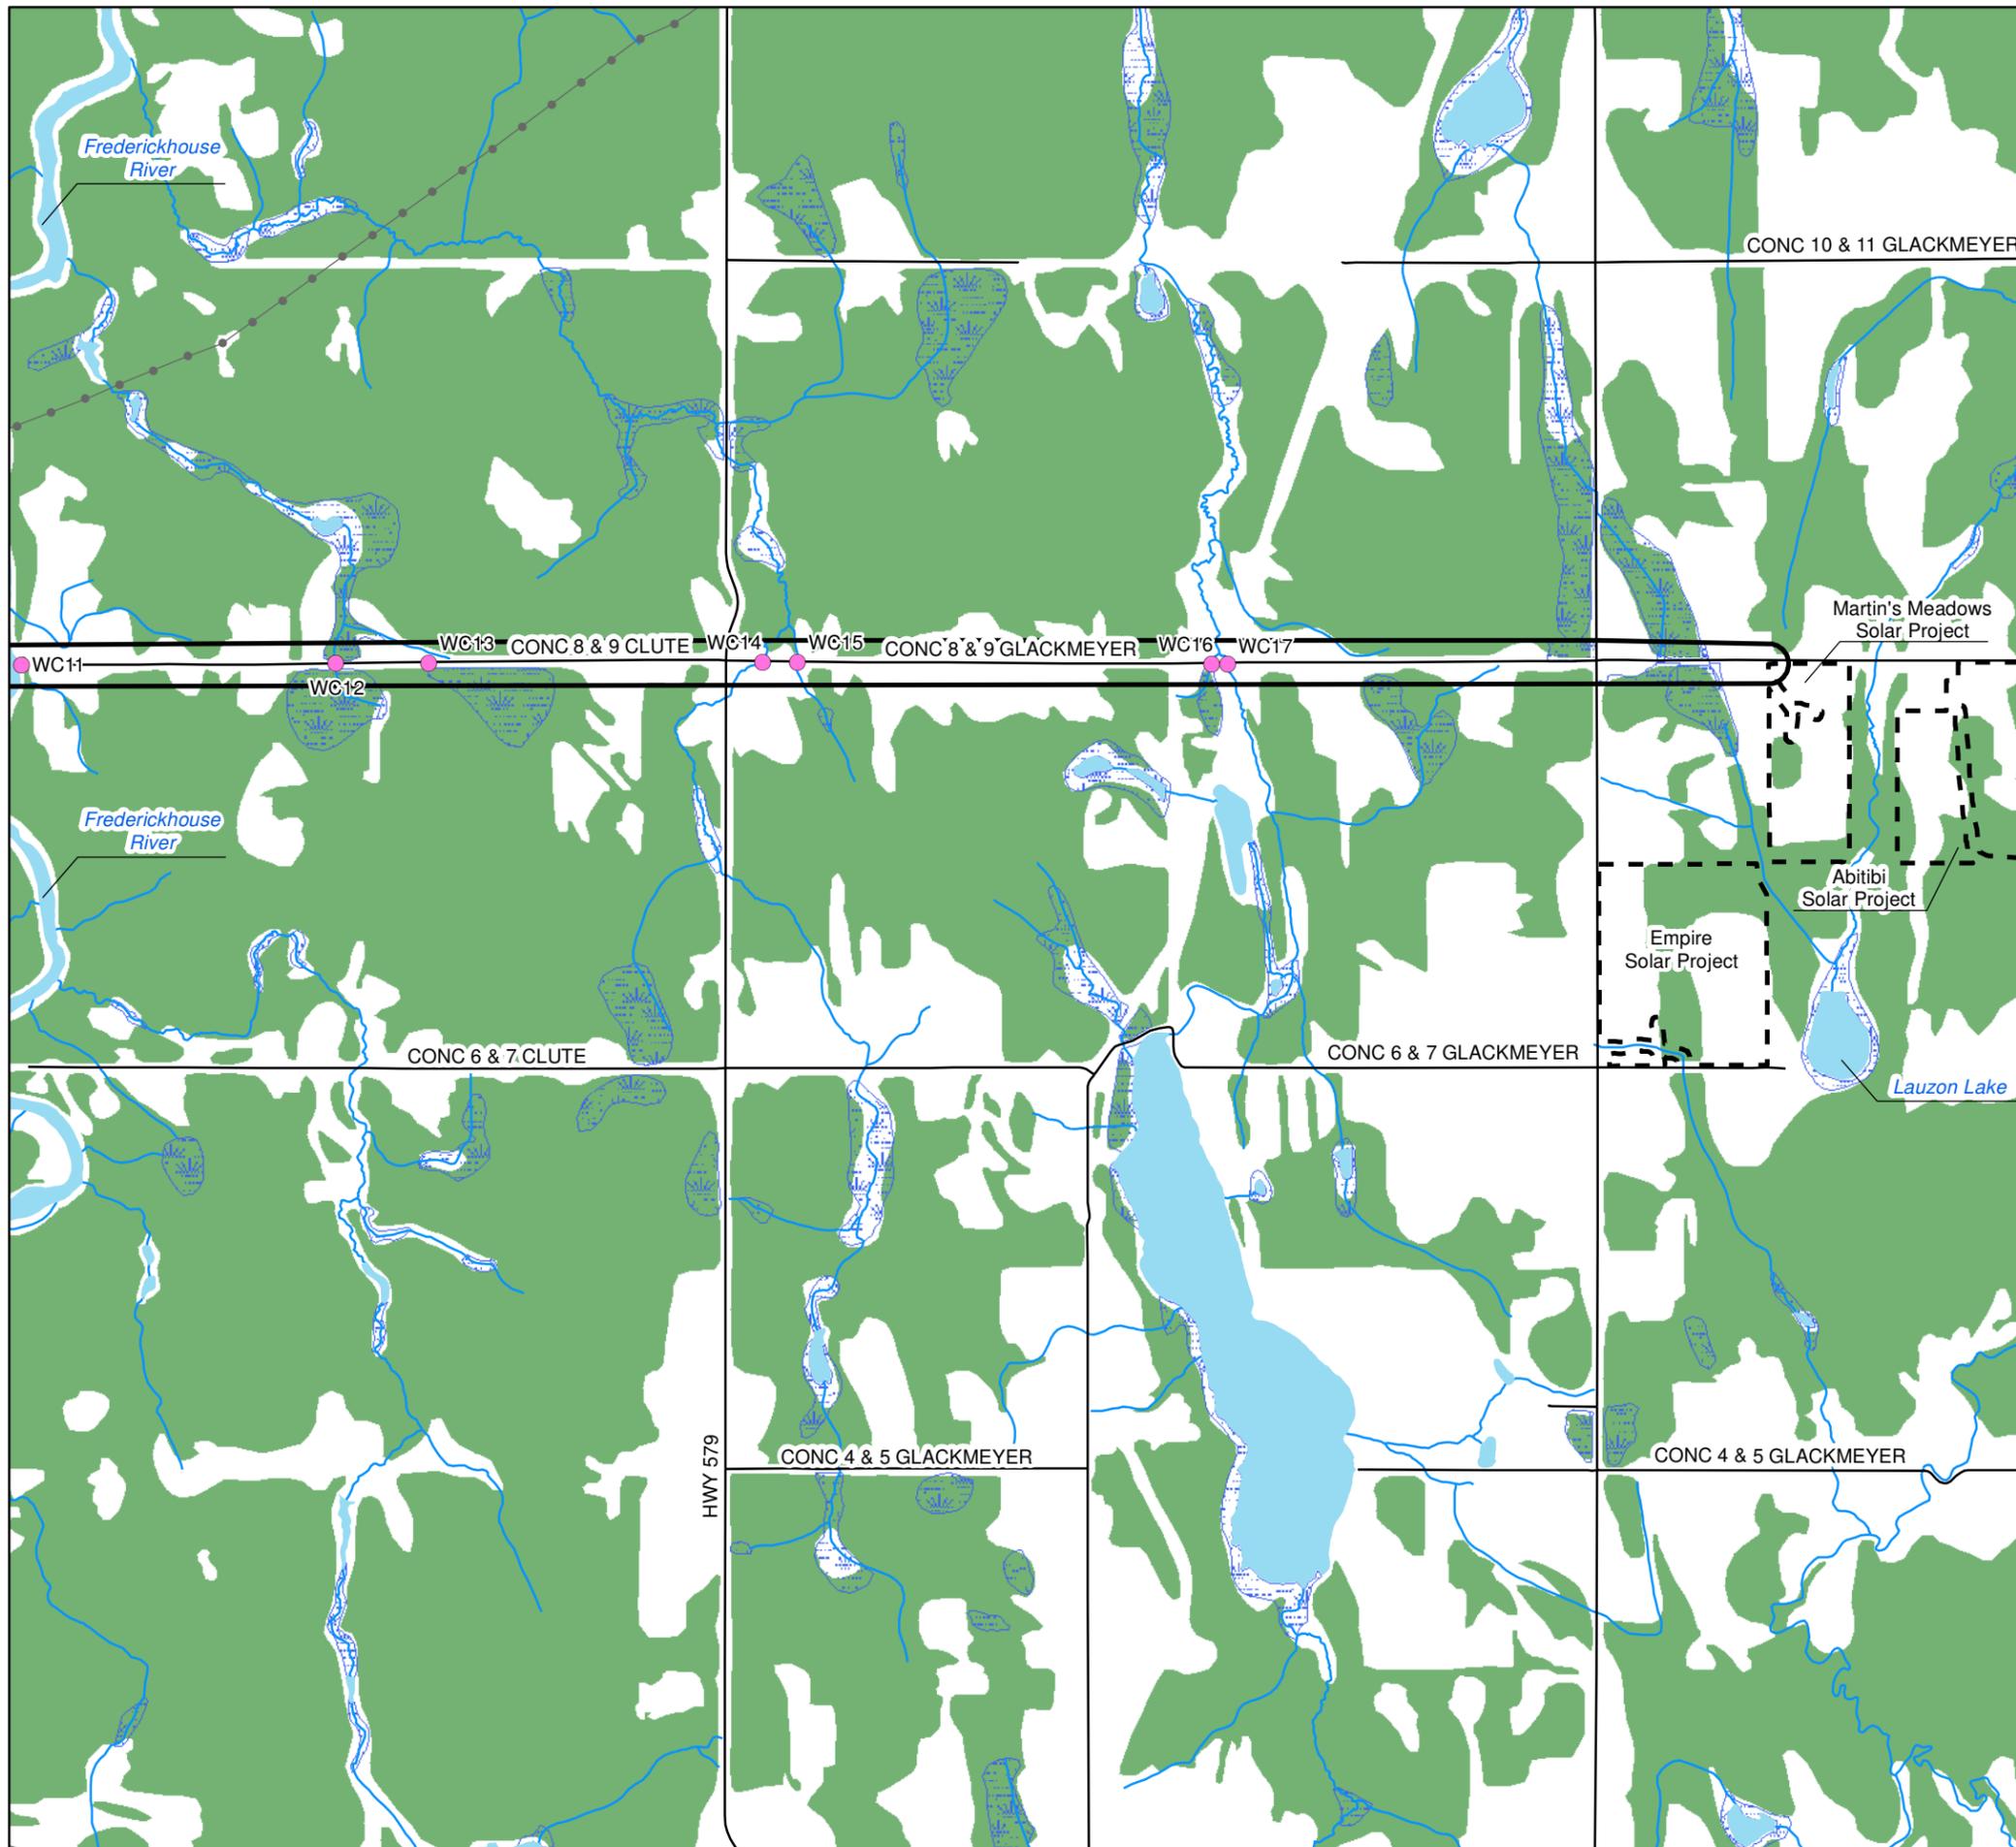
Figure 1.2
 Northland Power Inc.
**Transmission Line Project Location
 (Eastern Half) - Waterbody
 Site Investigation Results**

A total of 38 waterbodies were observed along the transmission line route options, as shown in Figures 1.2 and 1.3, and summarized in Table 4.1, which presents the watercourse identifier (as labelled on Figures 1.2 and 1.3), summary of watercourse observations (watercourse type, average width and depth, substrate, bank vegetation and other observations). There were 36 unnamed watercourses, the Frederickhouse River and Deception Creek. In addition, the proposed transmission line will pass within 120 m of Lower Deception Lake.

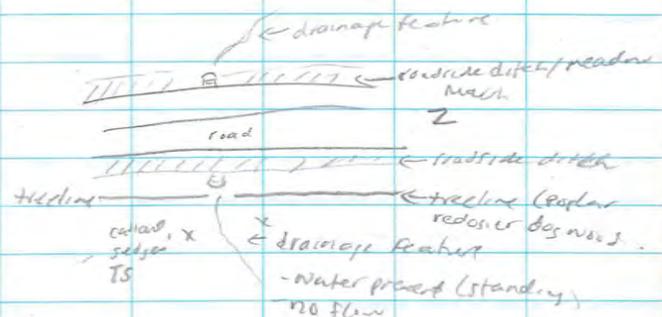
Drainage Feature / Wetland
culvert under road - east & west

- west side - ~~no~~ defined bank, low-lying area / meadow-march - grasses, sedges, cattail

- East side

- drainage swale east into "meadow-march"
